CITY OF NOVI CITY COUNCIL
MARCH 18, 2024

SUBJECT: Adoption of a Resolution requesting the Michigan Department of Transportation (MDOT) include the existing bridge on Ashbury Drive over the Middle Branch of the Rouge River in the State Local Bridge Program List for Replacement. If MDOT selects the bridge, the City of Novi will accept 100% of the design engineering costs and 5% of the total construction cost.

STR 13828		BRIDGE SAFETY INSPECTION REPORT		
Facility ASHBURY DRIVE	Latitude / Longitude 42.4427 / -83.4728	MDOT Structure ID 635489000067B01	Structure Condition Poor Condition(4)

Feature MIDDLE BR ROUGE RIVER	Length / Width / Spans 46.1 / 44.4 / 1	Owner City: NOVI(4890)		
Location CHASE FARMS SUBDIVISION	Built / Recon. / Paint / Ovly. 1991 / / /	TSC Oakland(23)	Operational Status A Open, no restriction(A)	
Region / County Metro(7) / Oakland(63)	Material / Design 5 Prestressed Concrete / 05 Box Bm/Gird- Multiple	Last NBI Inspection 09/27/2023 / K7KK	Scour Evaluation 8 Stable Above Footing

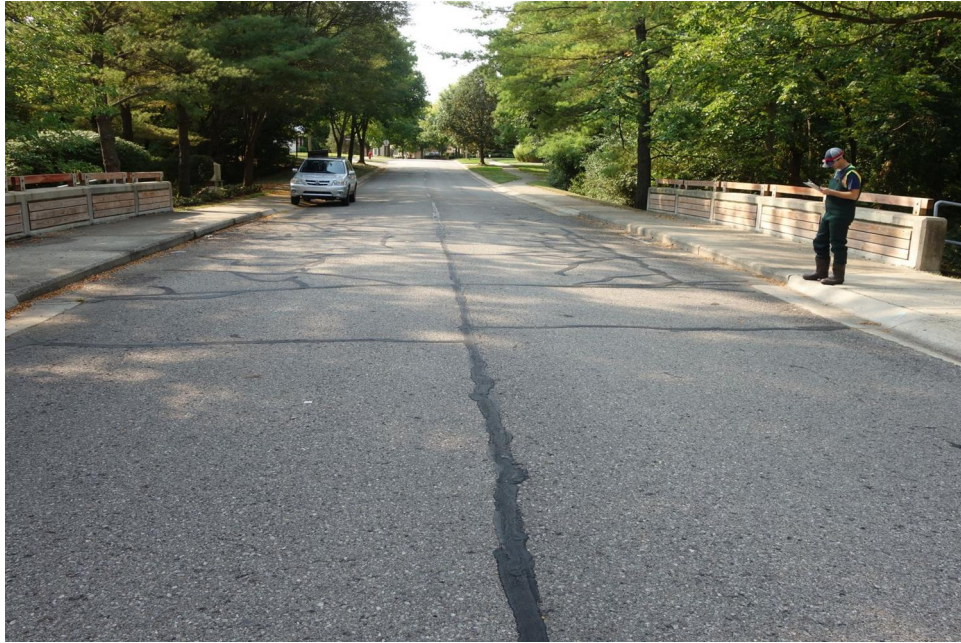
North Approach Looking South

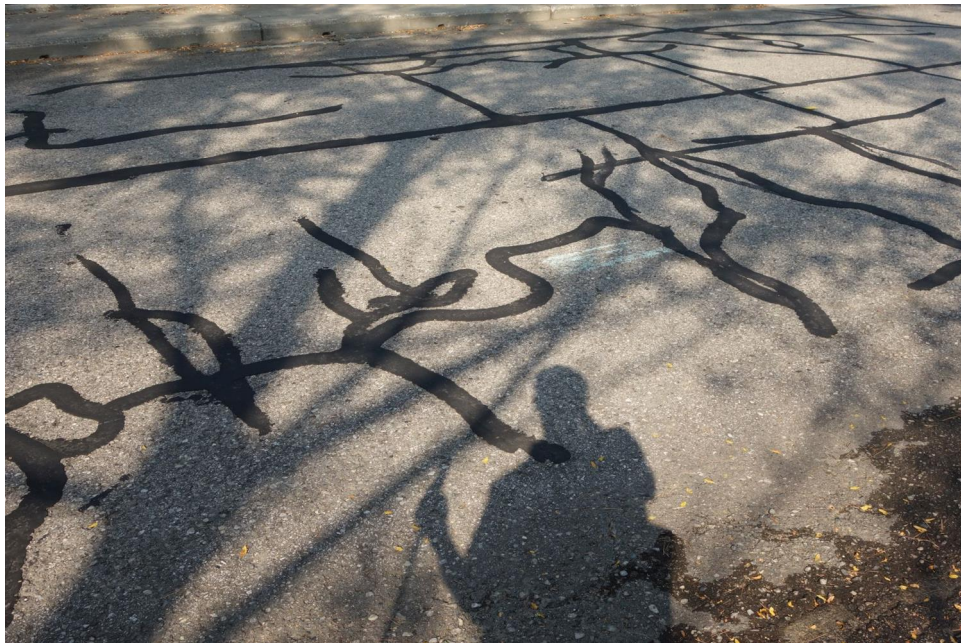
Typical Deck Surface

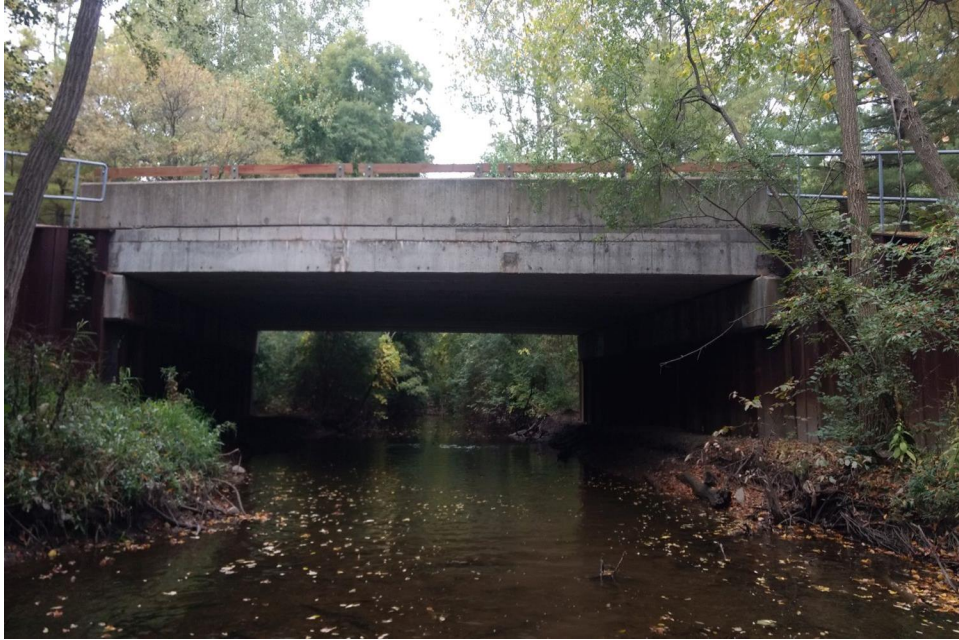
South Elevation

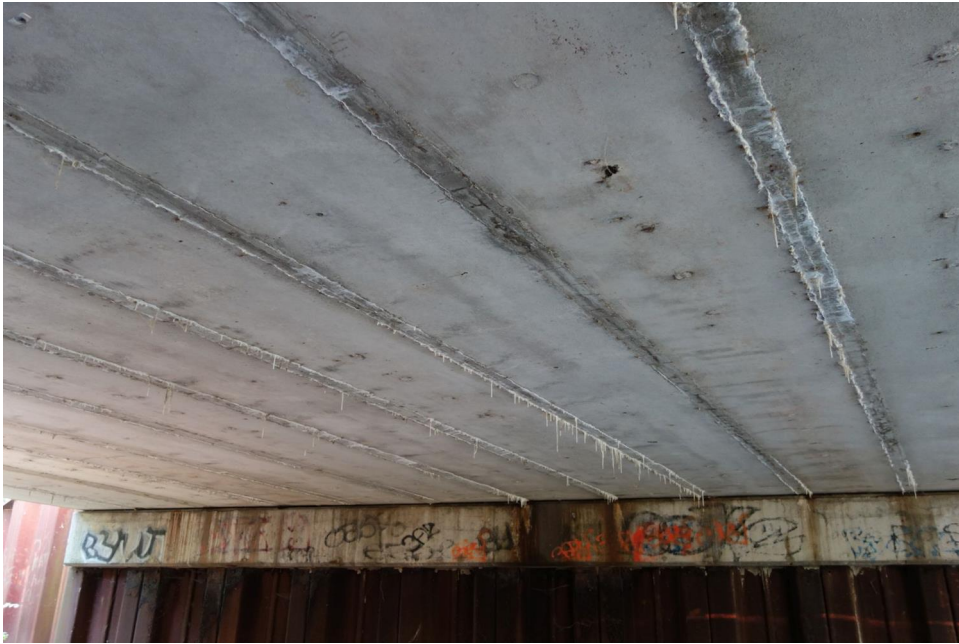
6. Deck Bottom Surface (SIA-58B)	N	N	N	Side-by-side box beams. Leaking between all beams. Stalactites present at most beam lines and leachate at all of them. (09/23) Side-by-side box beams. Leaking between all beams. Stalactites present at most beam lines and leachate at all of them. (09/22) Side-by-side box beams. Leaking between all beams. Stalactites present at most beam lines and leachate at all of them. (09/20)

Typical Deck Underside

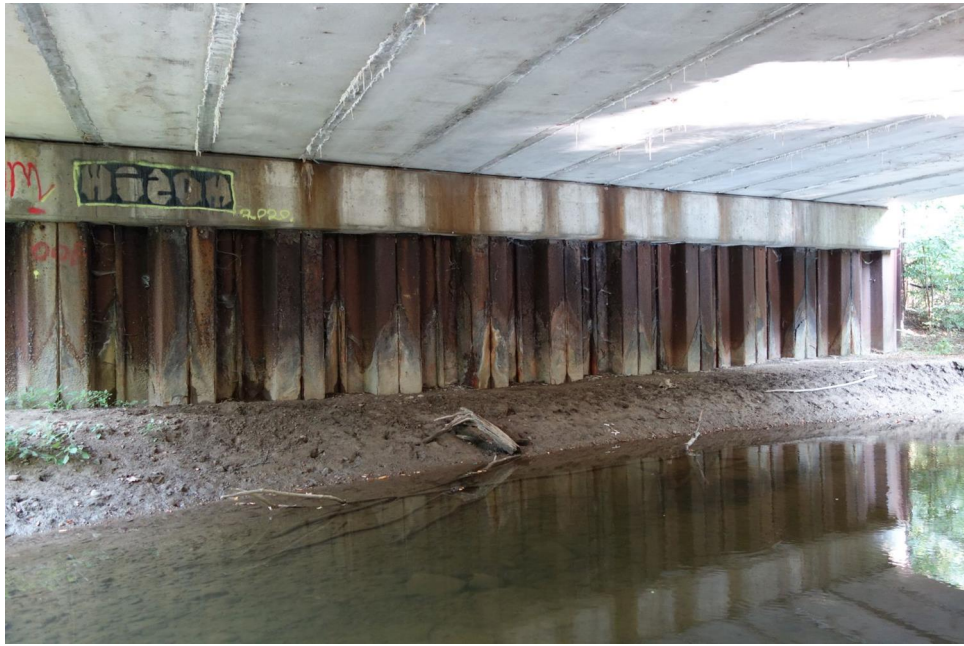
North Abutment

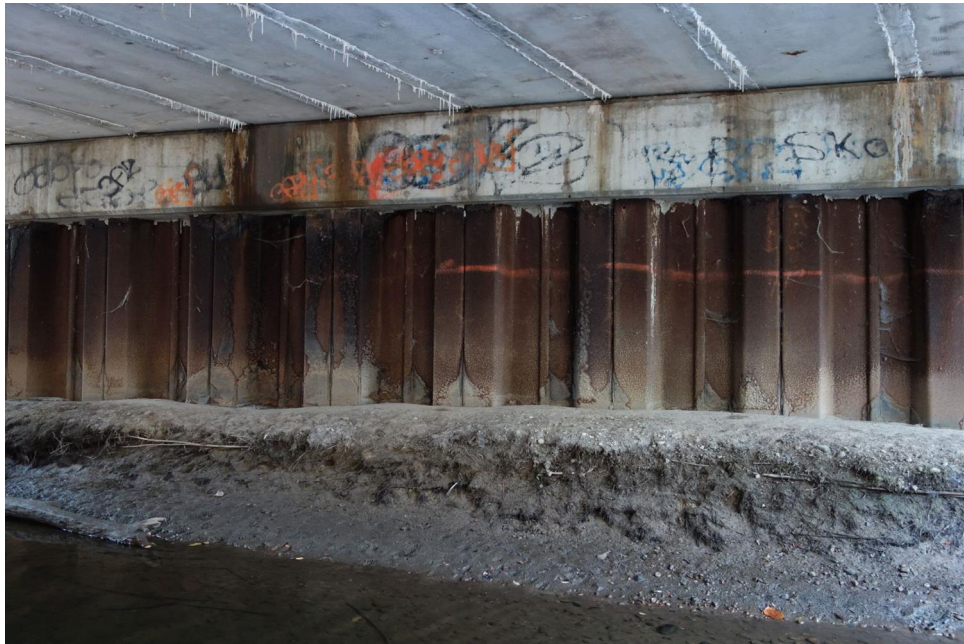
South Abutment

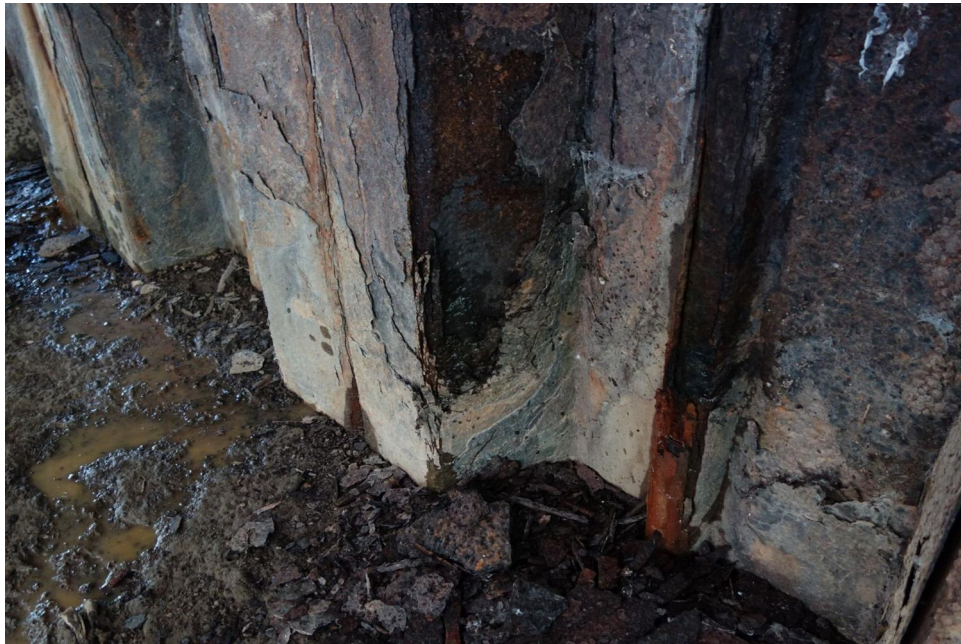
13. Abutments (SIA-60)	5	4	4	Pack rust and scaling at base and top near beams is evident on both abutments and has progressed since the previous inspection. Some vertical cracks in concrete pile cap. Evidence of leaking from ends. Holes in sheet piling of north abutment near the middle of the base. Pack rust and scaling on north abutment is allowing water through but no material. Section loss is minor and there is leaching between the sheets of the southern abutment sheet piling. Hole near top of sheet pile reveals that the bridge is on pipe piles and the sheet piles are used as earth retention only. (09/23) Pack rust and scaling at base and top near beams is evident on both abutments and has progressed since the previous inspection. Some vertical cracks in concrete pile cap. Evidence of leaking from ends. Holes in sheet piling of north abutment near the middle of the base. Pack rust and scaling on north abutment is allowing water through but no material. Section loss is minor and there is leaching between the sheets of the southern abutment sheet piling. (09/22) Steel sheet piling has pack rust at base and at top near beams. Section loss is minor and there is leaching between the sheets. Some vertical cracks in concrete pile cap. Evidence of leaking from ends. (09/20)

North Abutment Sheeting Section Loss and Rusting

The current structure is a single span adjacent concrete box beam bridge. The overall condition of the bridge is poor and rated a 4. The superstructure is in good condition. The surface is HMA with sealed cracks in fair condition. The concrete box beams have leaching between beams and a few cracks on the fascia beams with leaching. The abutments are in poor condition and rated a 4. The abutments are pipe pile supported concrete caps, with steel sheet piling below the concrete cap to retain the approach backfill. The sheet piling has extensive pack rust at the base and top near the beams. The north abutment sheet piling has holes near the middle of the base and the pack rust and scaling on the north abutment is allowing water through. Pack rust and section loss on the south abutment is moderate and there is leaching between pile sheets. The rate of deterioration has accelerated since the last inspection.

Recommendation Type	Priority	Description
Deck Patching	L	Seal cracks in surface.
HMA Overlay	L	Apply waterproofing underneath HMA overlay.
Substr Repair	M	Replace abutment sheet pile facing with more permanent solution.

Due to the poor condition of the abutment sheet piling, a partial substructure replacement is recommended. As the sheet piling continues to deteriorate, backfill material will spill through the abutment, causing sinkholes in the approaches. Repairing the existing holes is not recommended as the existing sheet piling will continue to deteriorate outside of the repairs. The bridge is supported on piles and a pile cap. The pile cap is in good condition and does not need to be replaced. A new concrete earth retaining system will be poured to protect and provide bracing to the existing piles and replace the existing sheet pile. To replace the substructure, the approaches and approach fill must be removed. New HMA and waterproofing membrane will be placed on the

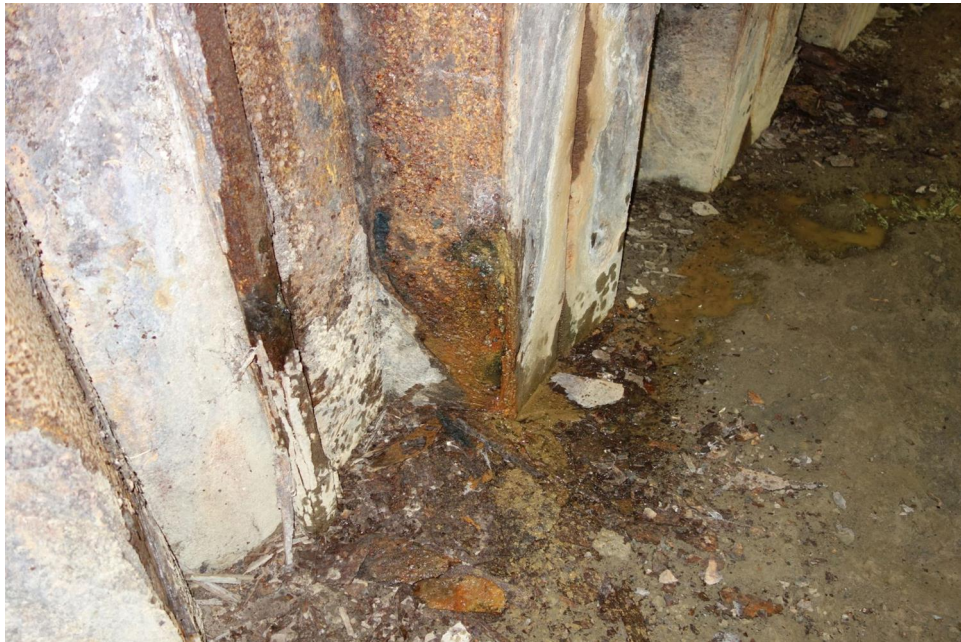
South Abutment Sheeting Section Loss and Rusting
