# **FIRE STATION NO. 3 LONG TERM NEEDS ASSESSMENT**

## EXISTING FACILITY ASSESSMENT

On November 8, 2013, Sidock Architects conducted an on-site inspection and analysis of Fire Station No. 3 with the assistance of the Novi Fire Department administration and staff, and representatives from the City of Novi Facility Operations. The inspection included brief discussions with the fire fighters and staff at the station and a general inspection tour of the facility.

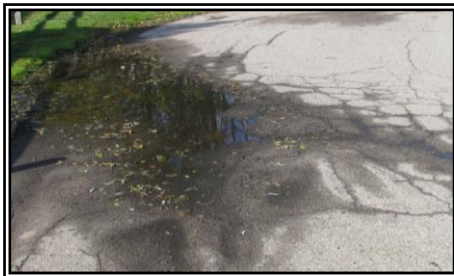
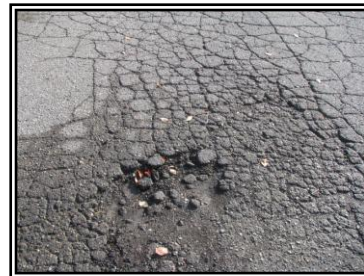
1. Parking is adequate for the current staffing.
2. The concrete apron at the egress side of the Apparatus Bay is adequate in length and in reasonably good condition.
3. The asphalt drive is in fair condition given the heavy vehicle traffic. The City has conducted a paving assessment and schedule for repair and/or replacement.

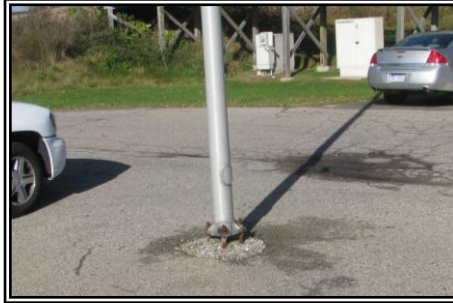
5. An existing light pole is located in the paved area on the west side of the site which needs to be replaced and relocated out of the vehicle drive area.

- A non-slip epoxy floor system should be applied in the Apparatus Bays.
- The site light in the rear drive should be replaced and relocated out of the driveway.
- Additional space should be added to provide a separate locker room or a separation concept to divide the locker room area from the sleeping area.
- Additional space should be added to provide and consolidate storage.

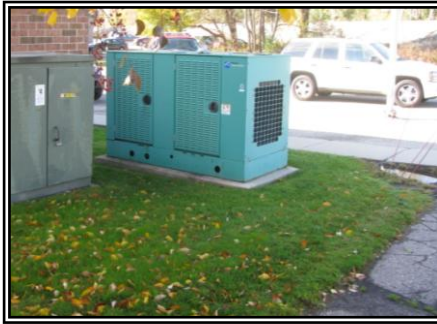
6. The emergency generator and the electrical transformer are located close to the drive on the north side of the station, and should have bumper posts added for protection from vehicles backing out of the parking spaces on the north side of the site and from vehicle traffic along the drive.

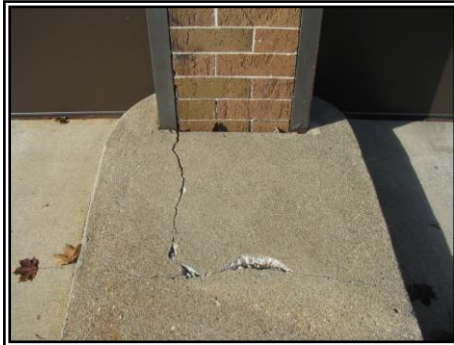
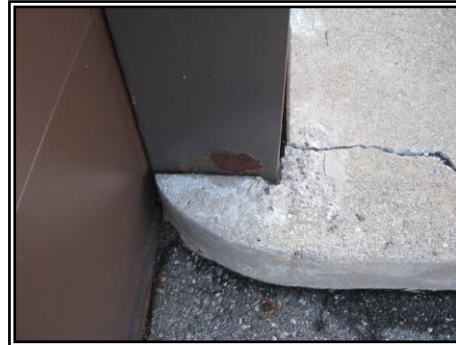
7. There is some cracking of concrete curbs adjacent to the overhead doors.

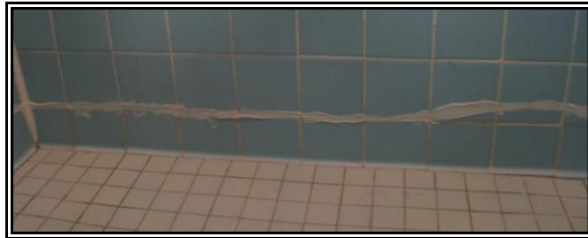
- 6. Men's Toilet/Shower Room
  - a. Ceramic tiles are cracked and/or missing in multiple locations – both wall tile and base.

- The asphalt paving has cracking, standing water ponding and is in poor condition. This may be addressed in the City's pavement assessment/replacement program.
- Exterior lintels, doors and windows need repainting.
- Minor brick tuck pointing is needed on the north elevation.
- Acoustical ceilings should be replaced throughout the station.
- Carpeting should be replaced throughout the station.
- Countertops and cabinets are in need of replacement.
- Toilet/shower rooms need to be updated and ceramic tile needs to be replaced. Toilet fixtures and partitions should also be replaced at the same time.
