SECTION 6 STREAMBANK STABILIZATION EVALUATION AND RECOMMENDATIONS

RE: Novi Stormwater Master Plan

Environmental Consulting & Technology, Inc. (ECT) has prepared the following summary of the streambank assessments and site investigations of Bishop Creek, Ingersol Creek, and the Middle Branch of the Rouge River for your use.

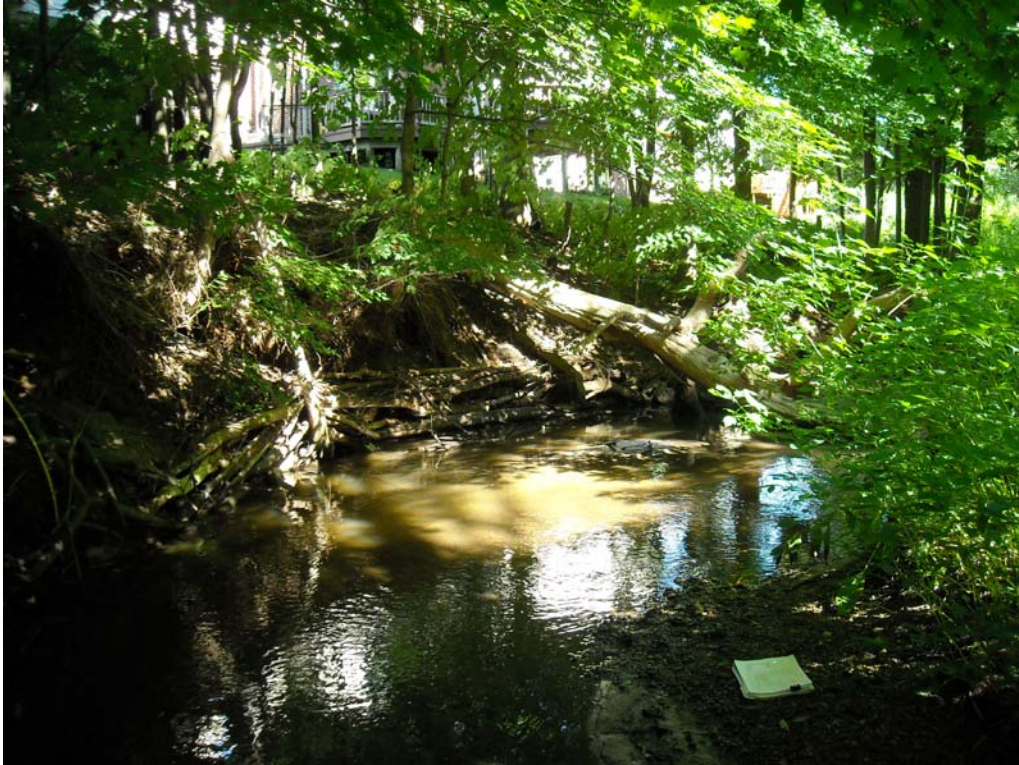
Picture: 187

Outside meander erosion, residential area, Bank Height = ~ 7', BEHI = 29/Very High

Location: **Bishop Creek**

Site: 4

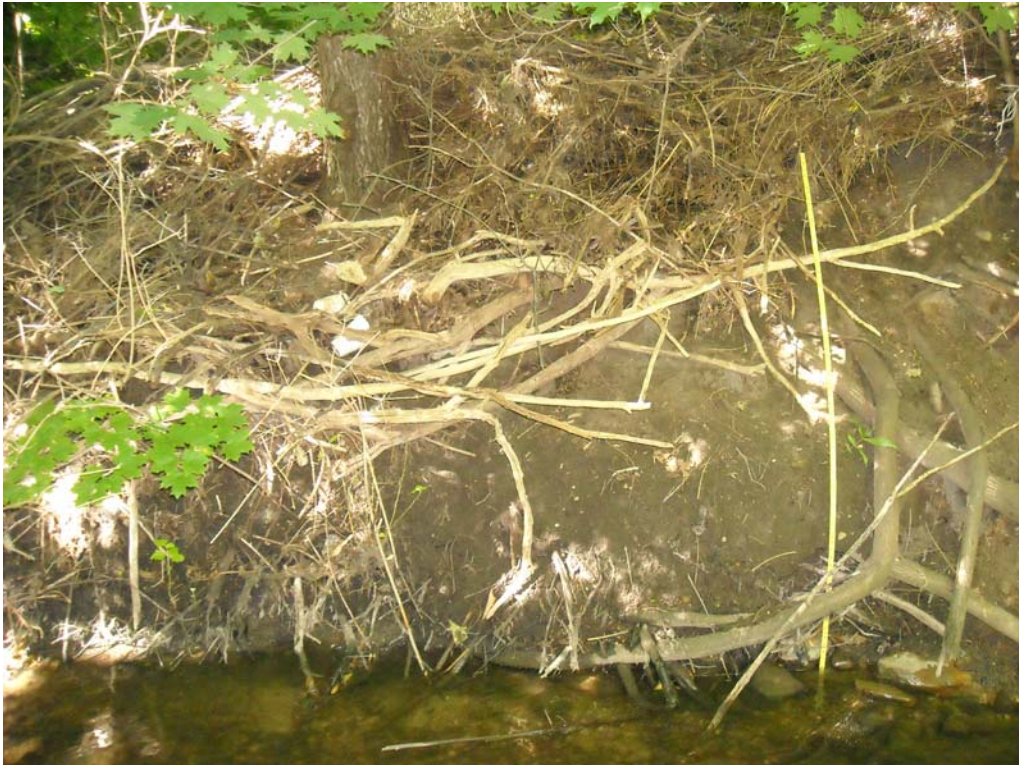
Picture: 182

Toe Erosion, downstream end of Site 4

Location: **Bishop Creek**

Site: 4

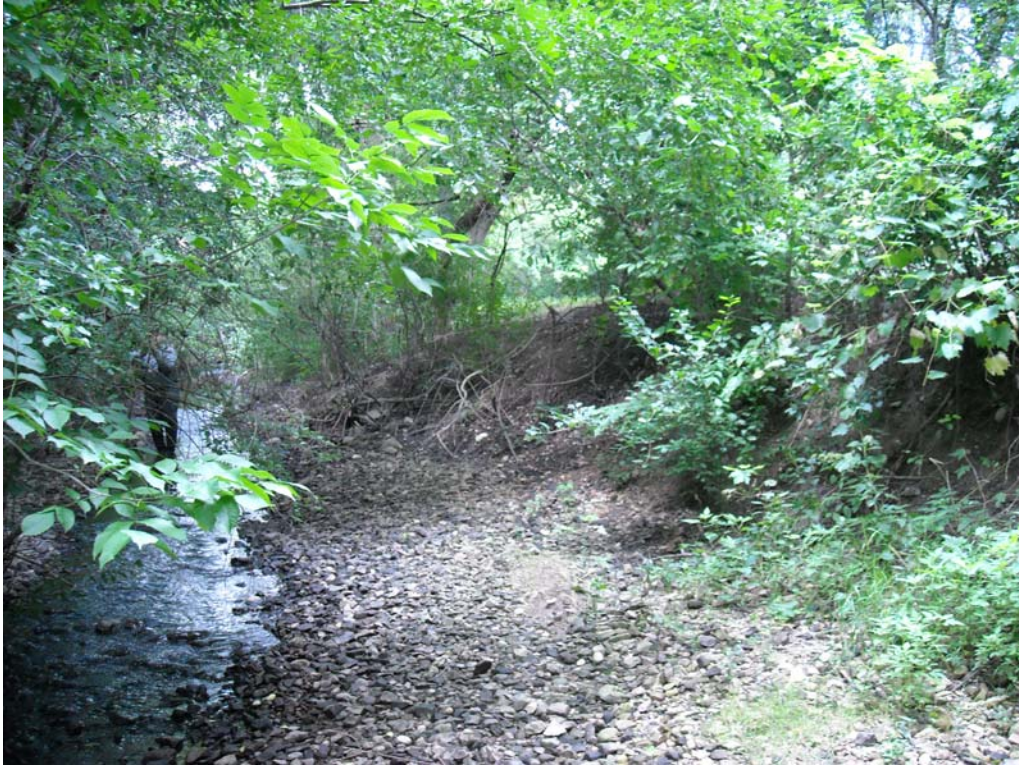
Picture: 251

Upper Bank Slope Failure, looking downstream, Bank Height = ~ 5.5', BEHI = 31/Very High

Location: **Ingersol Creek**

Site: 1

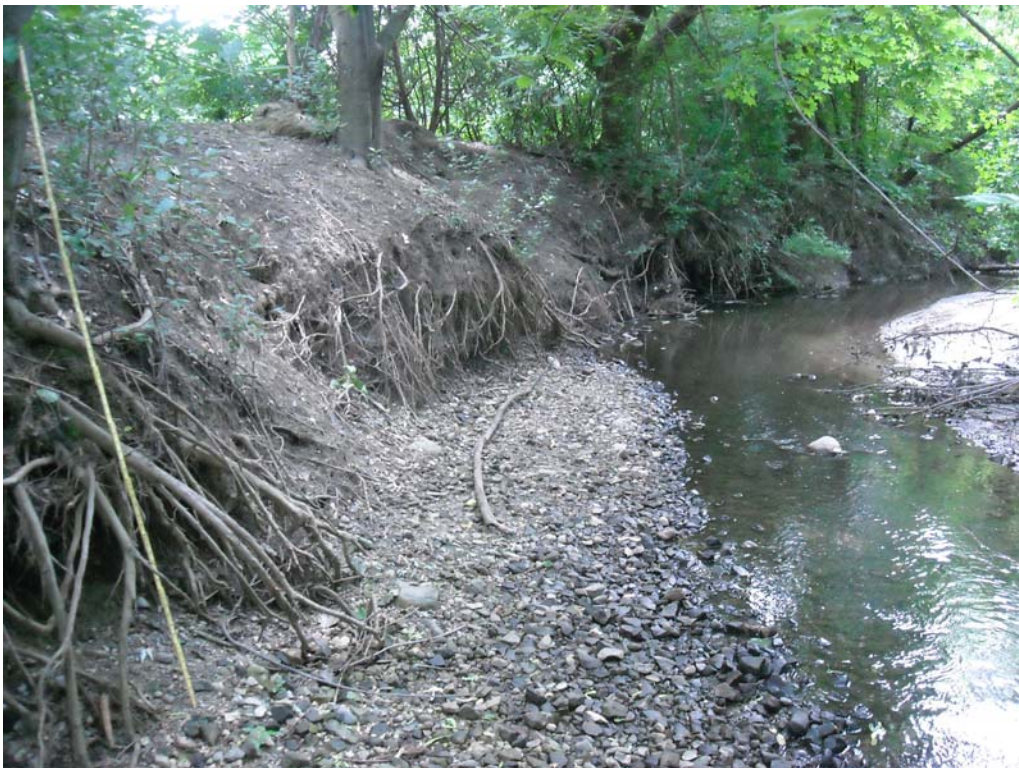
Picture: 256

Undercutting Bank, looking upstream, sediment deposit

Location: **Ingersol Creek**

Site: 1

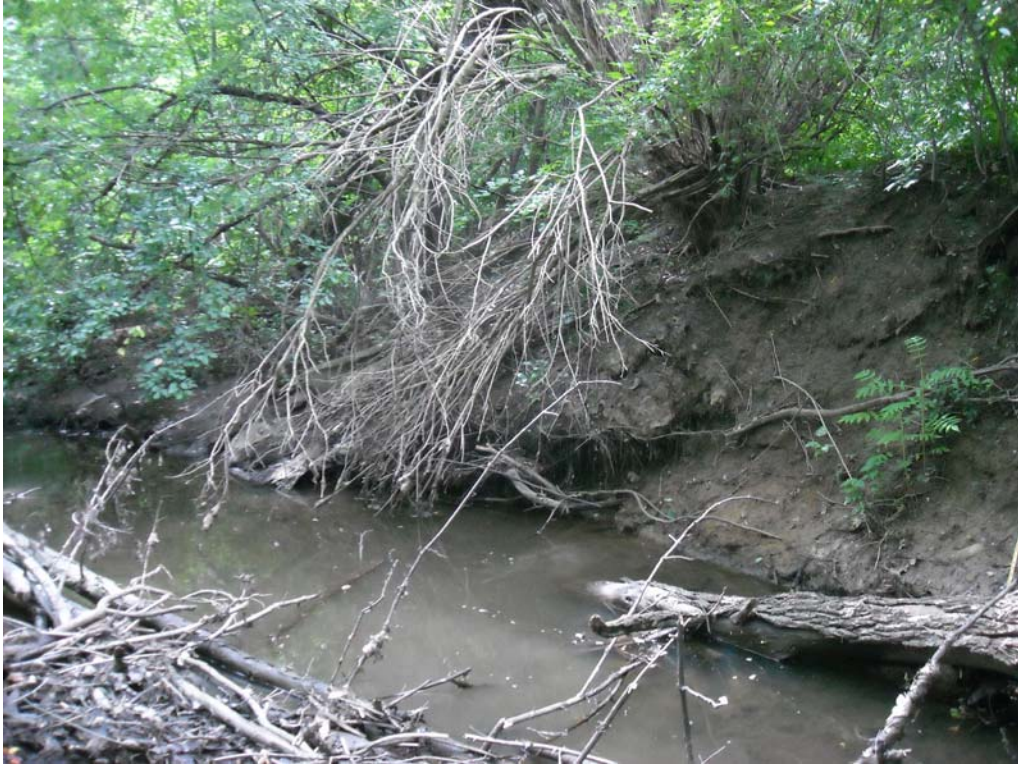
Picture: 275

Toe Scour and Bank Failure, Bank Height = ~ 7', BEHI = 31/Very High

Location: **Ingersol Creek**

Site: 5

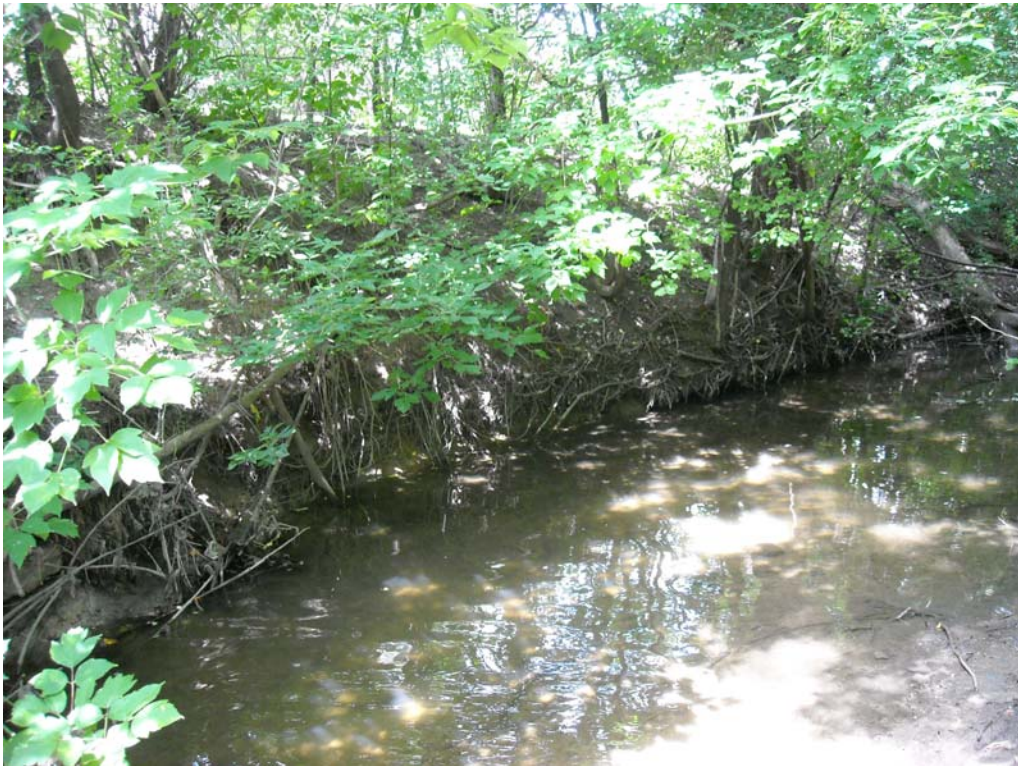
Picture: 273

Outside Meander Erosion

Location: **Ingersol Creek**

Site: 5

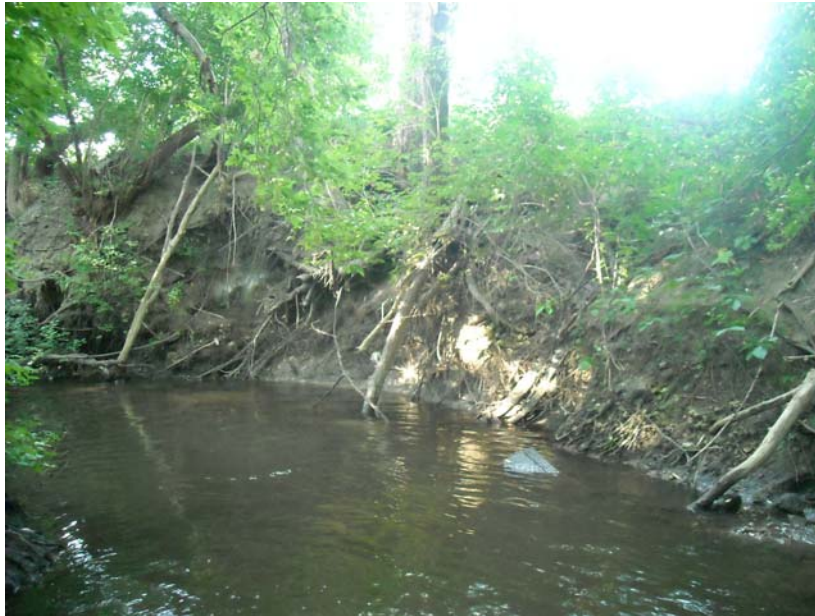
Picture: 365

Outside Meander Erosion, looking downstream, Bank Height = ~ 10', BEHI = 34/Very High

Location: **Middle Branch Rouge River**

Site: 7

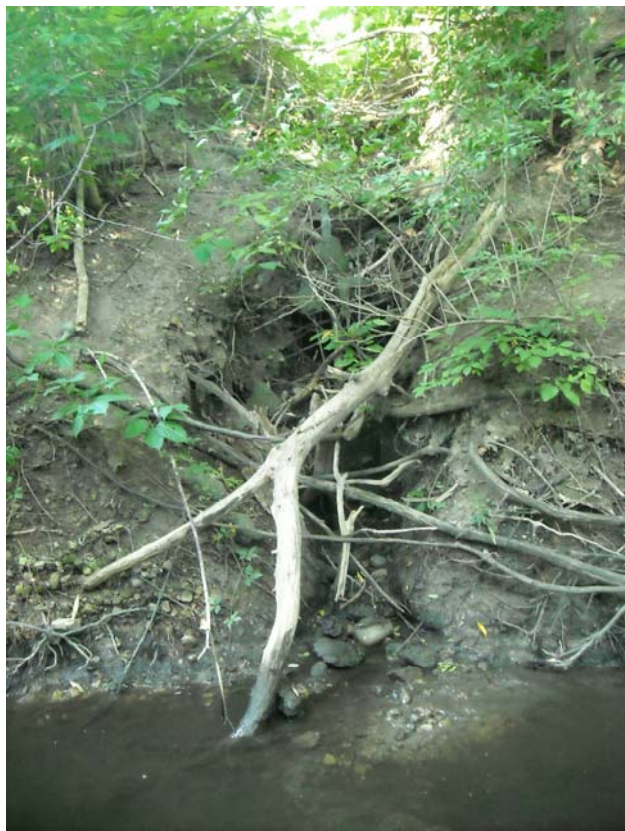
Picture: 369

Gully Erosion along Site 7

Location: **Middle Branch Rouge River**

Site: 7

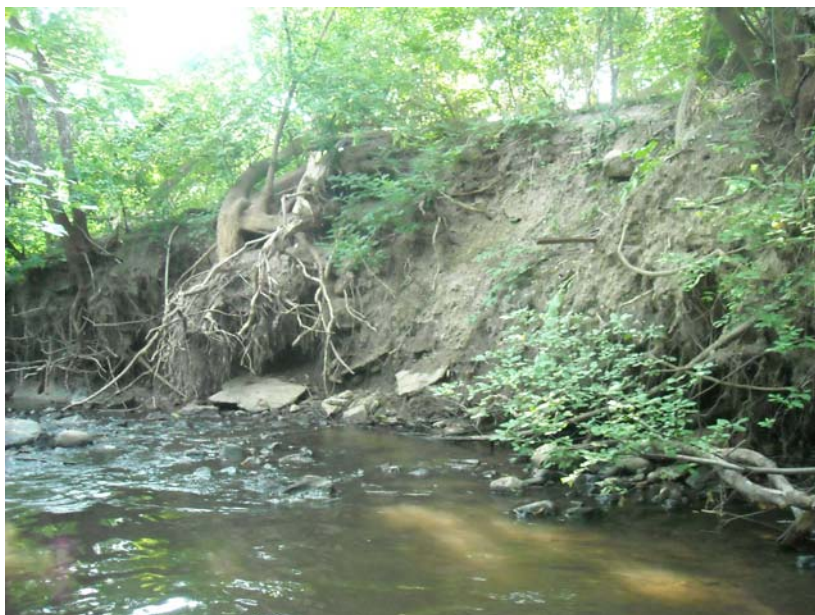
Picture: 373

Active Bank Erosion at downstream end of Site 7

Location: **Middle Branch Rouge River**

Site: 7

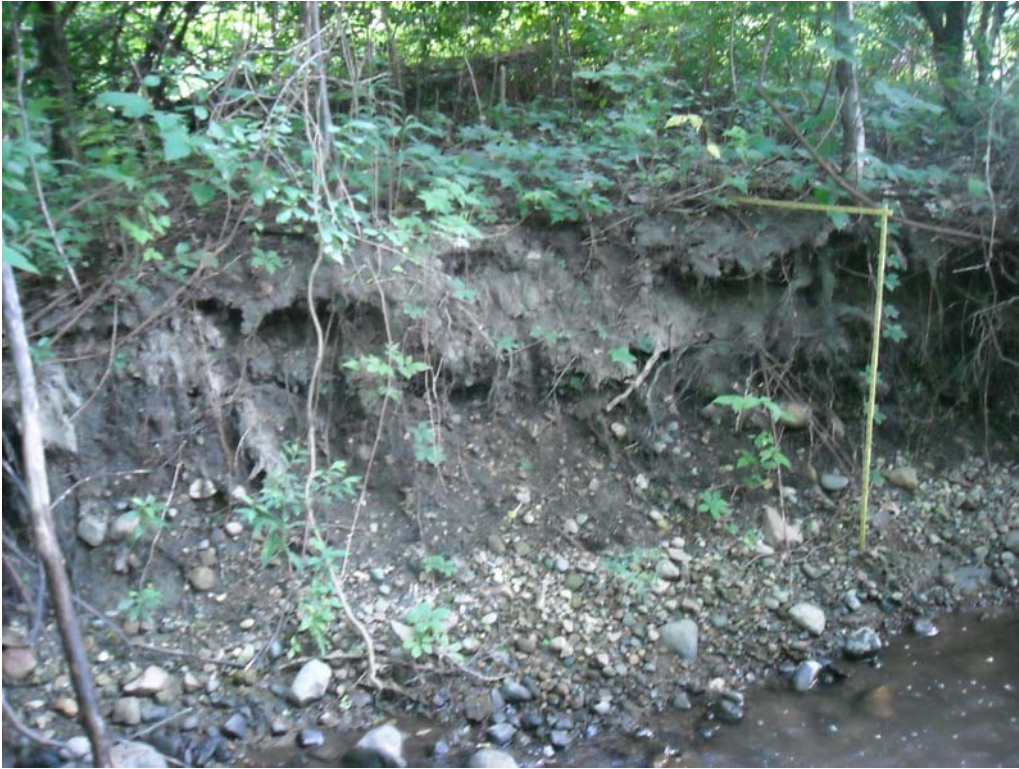
Picture: 379

Bank Failure, Bank Height = ~ 3.5', BEHI = 34/Very High

Location: **Middle Branch Rouge River**

Site: 8

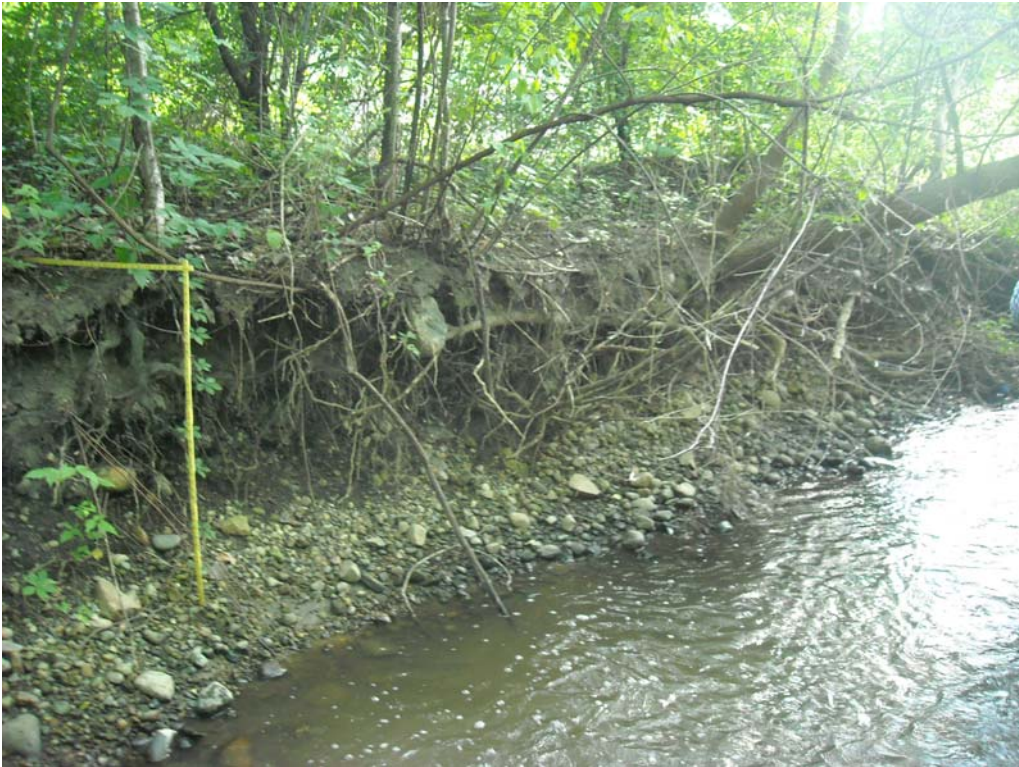
Picture: 381

Undercutting Bank, looking downstream

Location: **Middle Branch Rouge River**

Site: 8

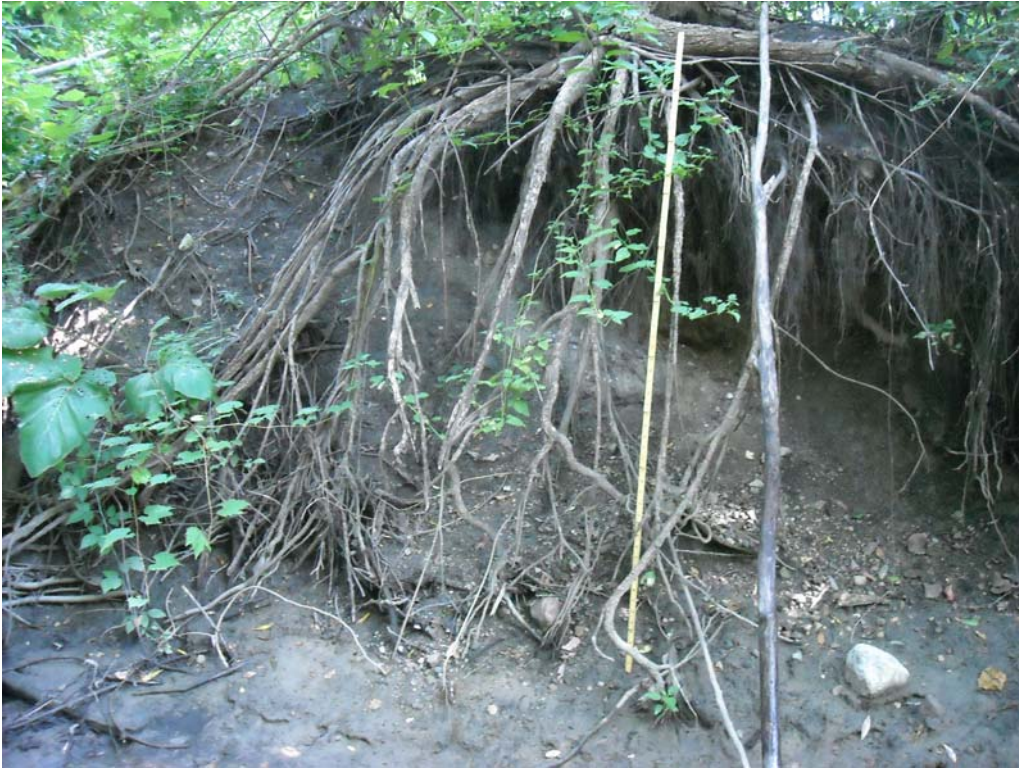
Picture: 408

Undercutting Bank, Bank Height = ~ 7', BEHI = 29/Very High

Location: **Middle Branch Rouge River**

Site: 14

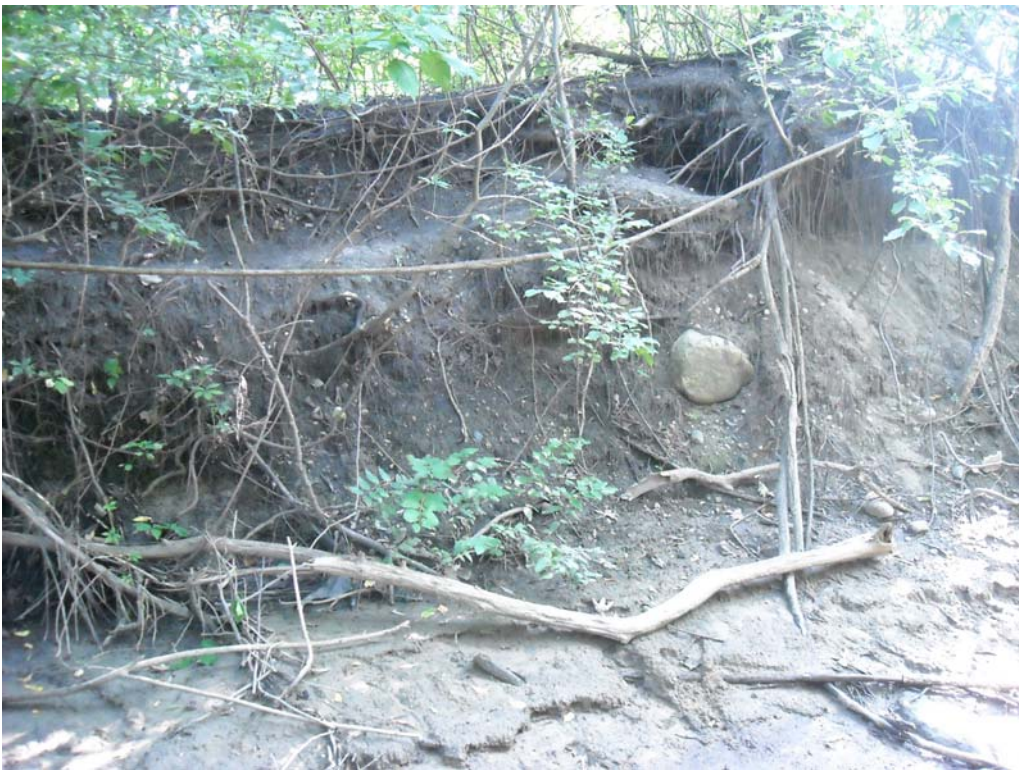
Picture: 411

Mass Wasting at Site 14

Location: **Middle Branch Rouge River**

Site: 14

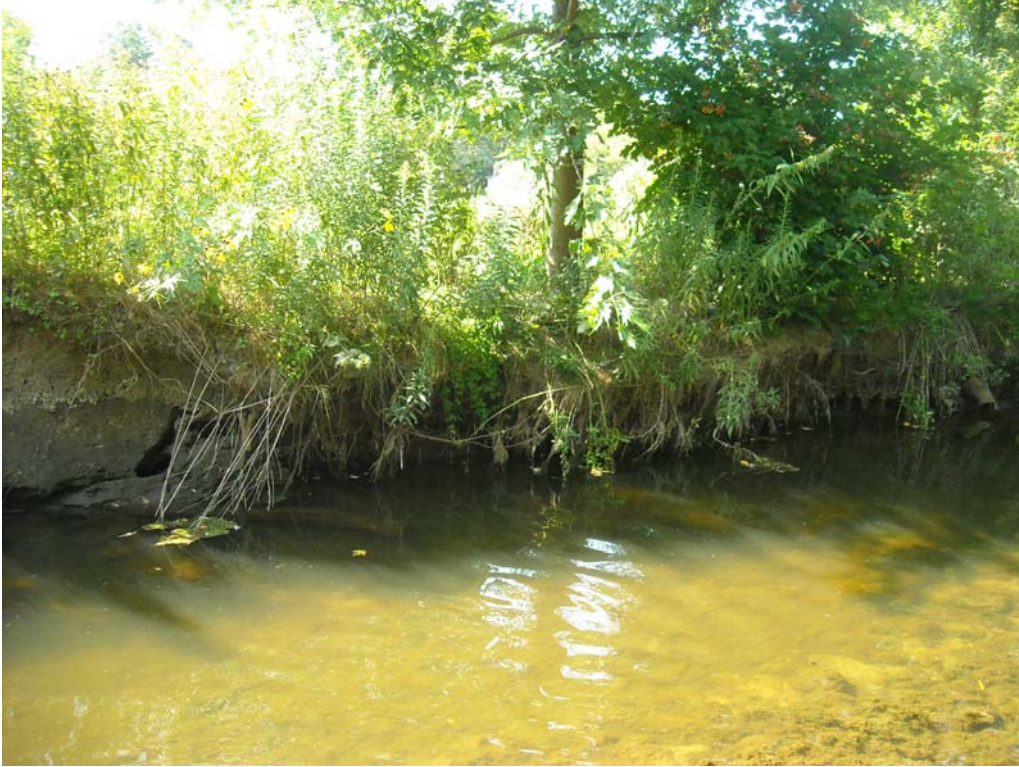
Picture: 476

Outside Meander Erosion & Undercutting Bank, Bank Height = ~ 3.5', BEHI =31/Very High

Location: **Middle Branch Rouge River**

Site: 26

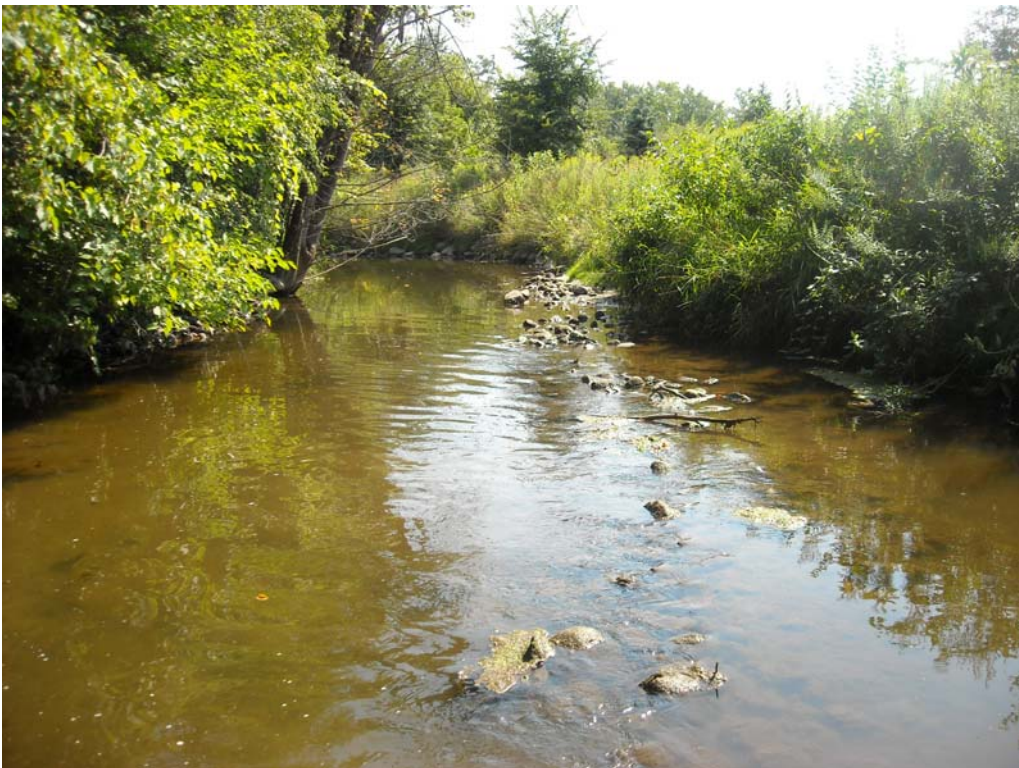
Picture: 481

Riprap in channel showing pre-erosion bank location (looking downstream)

Location: **Middle Branch Rouge River**

Site: 26

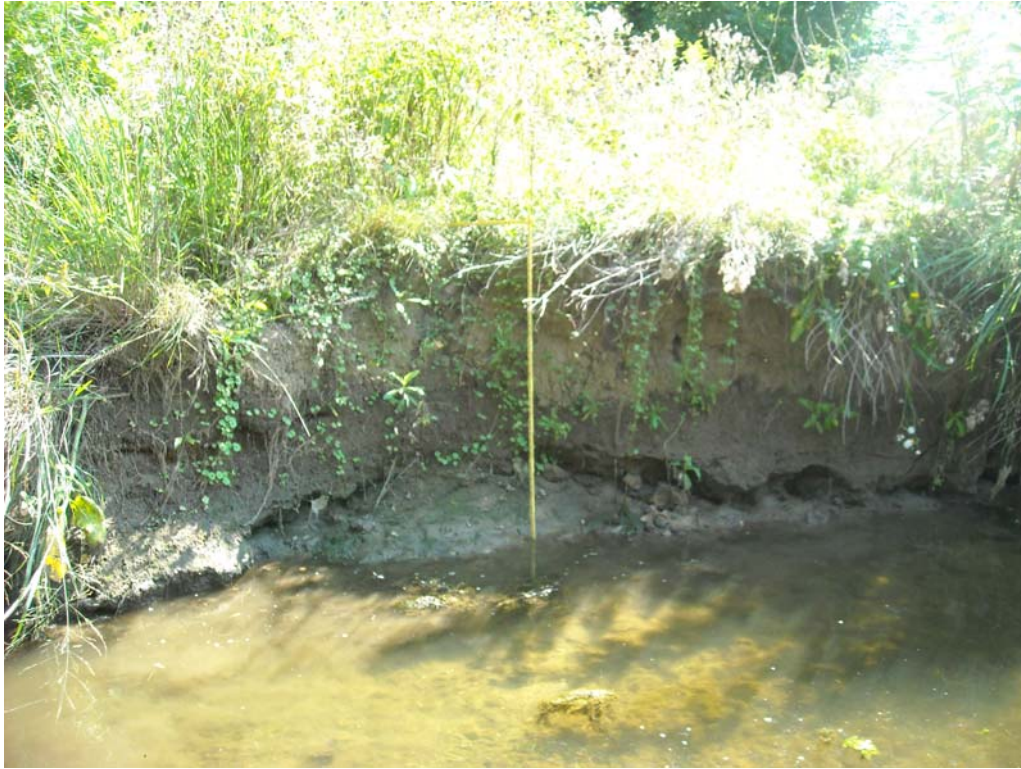
Picture: 483

Active Bank Failure and Slumping

Location: **Middle Branch Rouge River**

Site: 26

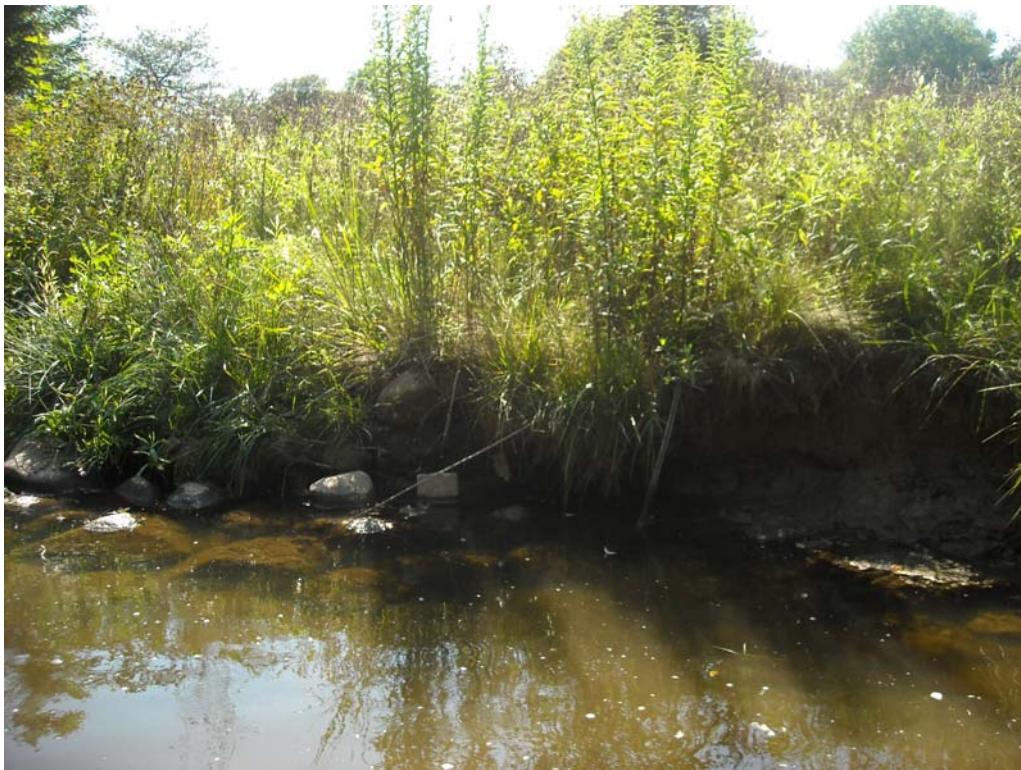
Picture: 501

Active Bank Failure and Slumping

Location: **Middle Branch Rouge River**

Site: 26
