CITY OF NOVI  
ADA COMPLIANCE TRANSITION PLAN  
CITY-OWNED FACILITIES  
MARCH 2014

SDA Job No. NV13006.0C

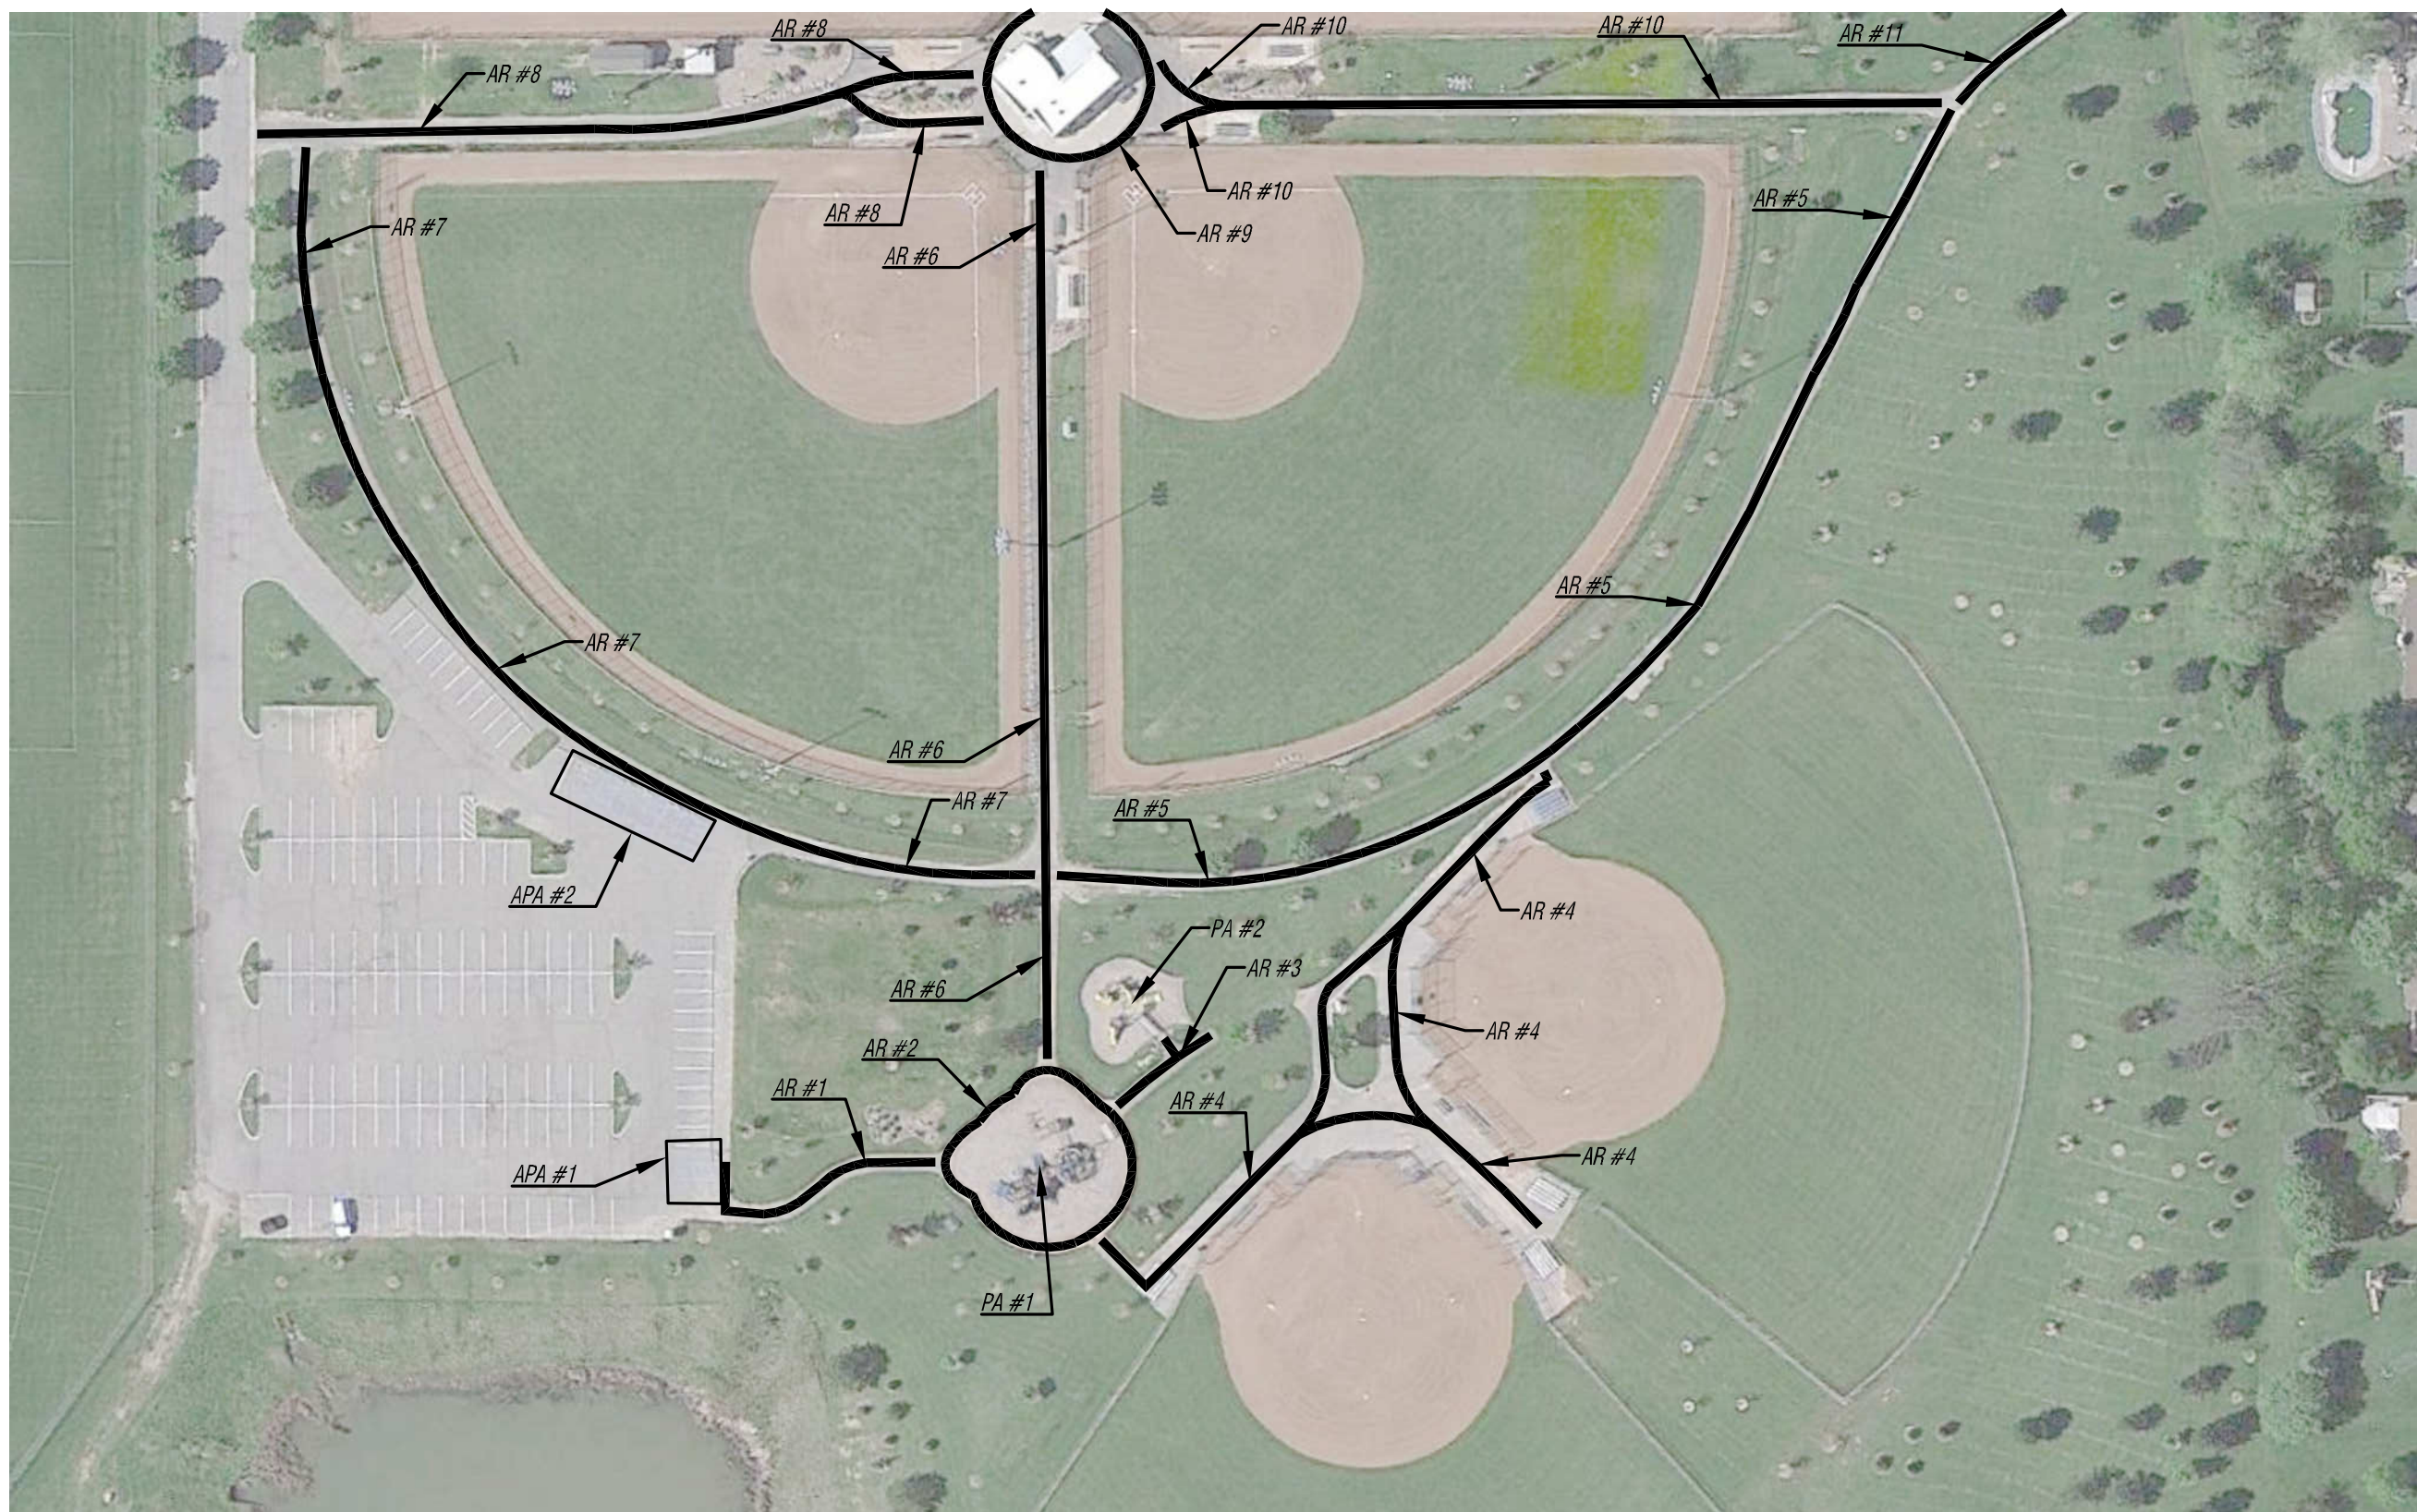
| SCALE:<br>NONE | SHEET<br>EMPP-1 |

| | Play Areas | | | | |
|---|---|---|---|---|---|
| 33 | Play Area PA#1 | Play Area | Play area surface is comprised of woodchips and is surrounded by a raised concrete curb border that does not allow a flush transition surface into the play area. | Install asphalt or concrete path with ADA compliant slopes cut into the existing curb border to allow flush access into the play area. Woodchip surface must be placed flush up against new path entrance into play area as well. | 1008.1 |
| 34 | Play Area PA#2 | Play Area | The accessible route leading up to the play area connects to an elevated bridge portion of the structure that leads to a slide down to the play area woodchip surface. Therefore, the play area surface is actually a level lower than the accessible route into the play area. The play area surface is then surrounded by a raised border with no accessible route out of the play area. Furthermore, there is a change in level where the ingress accessible route meets the play structure. | Provide flush transition from ingress accessible route to the elevated bridge portion of the play structure. Provide accessible route path with compliant slopes out of the play area surface that is flush with the play area woodchip surface, free of changes of level. | 1008.1 |

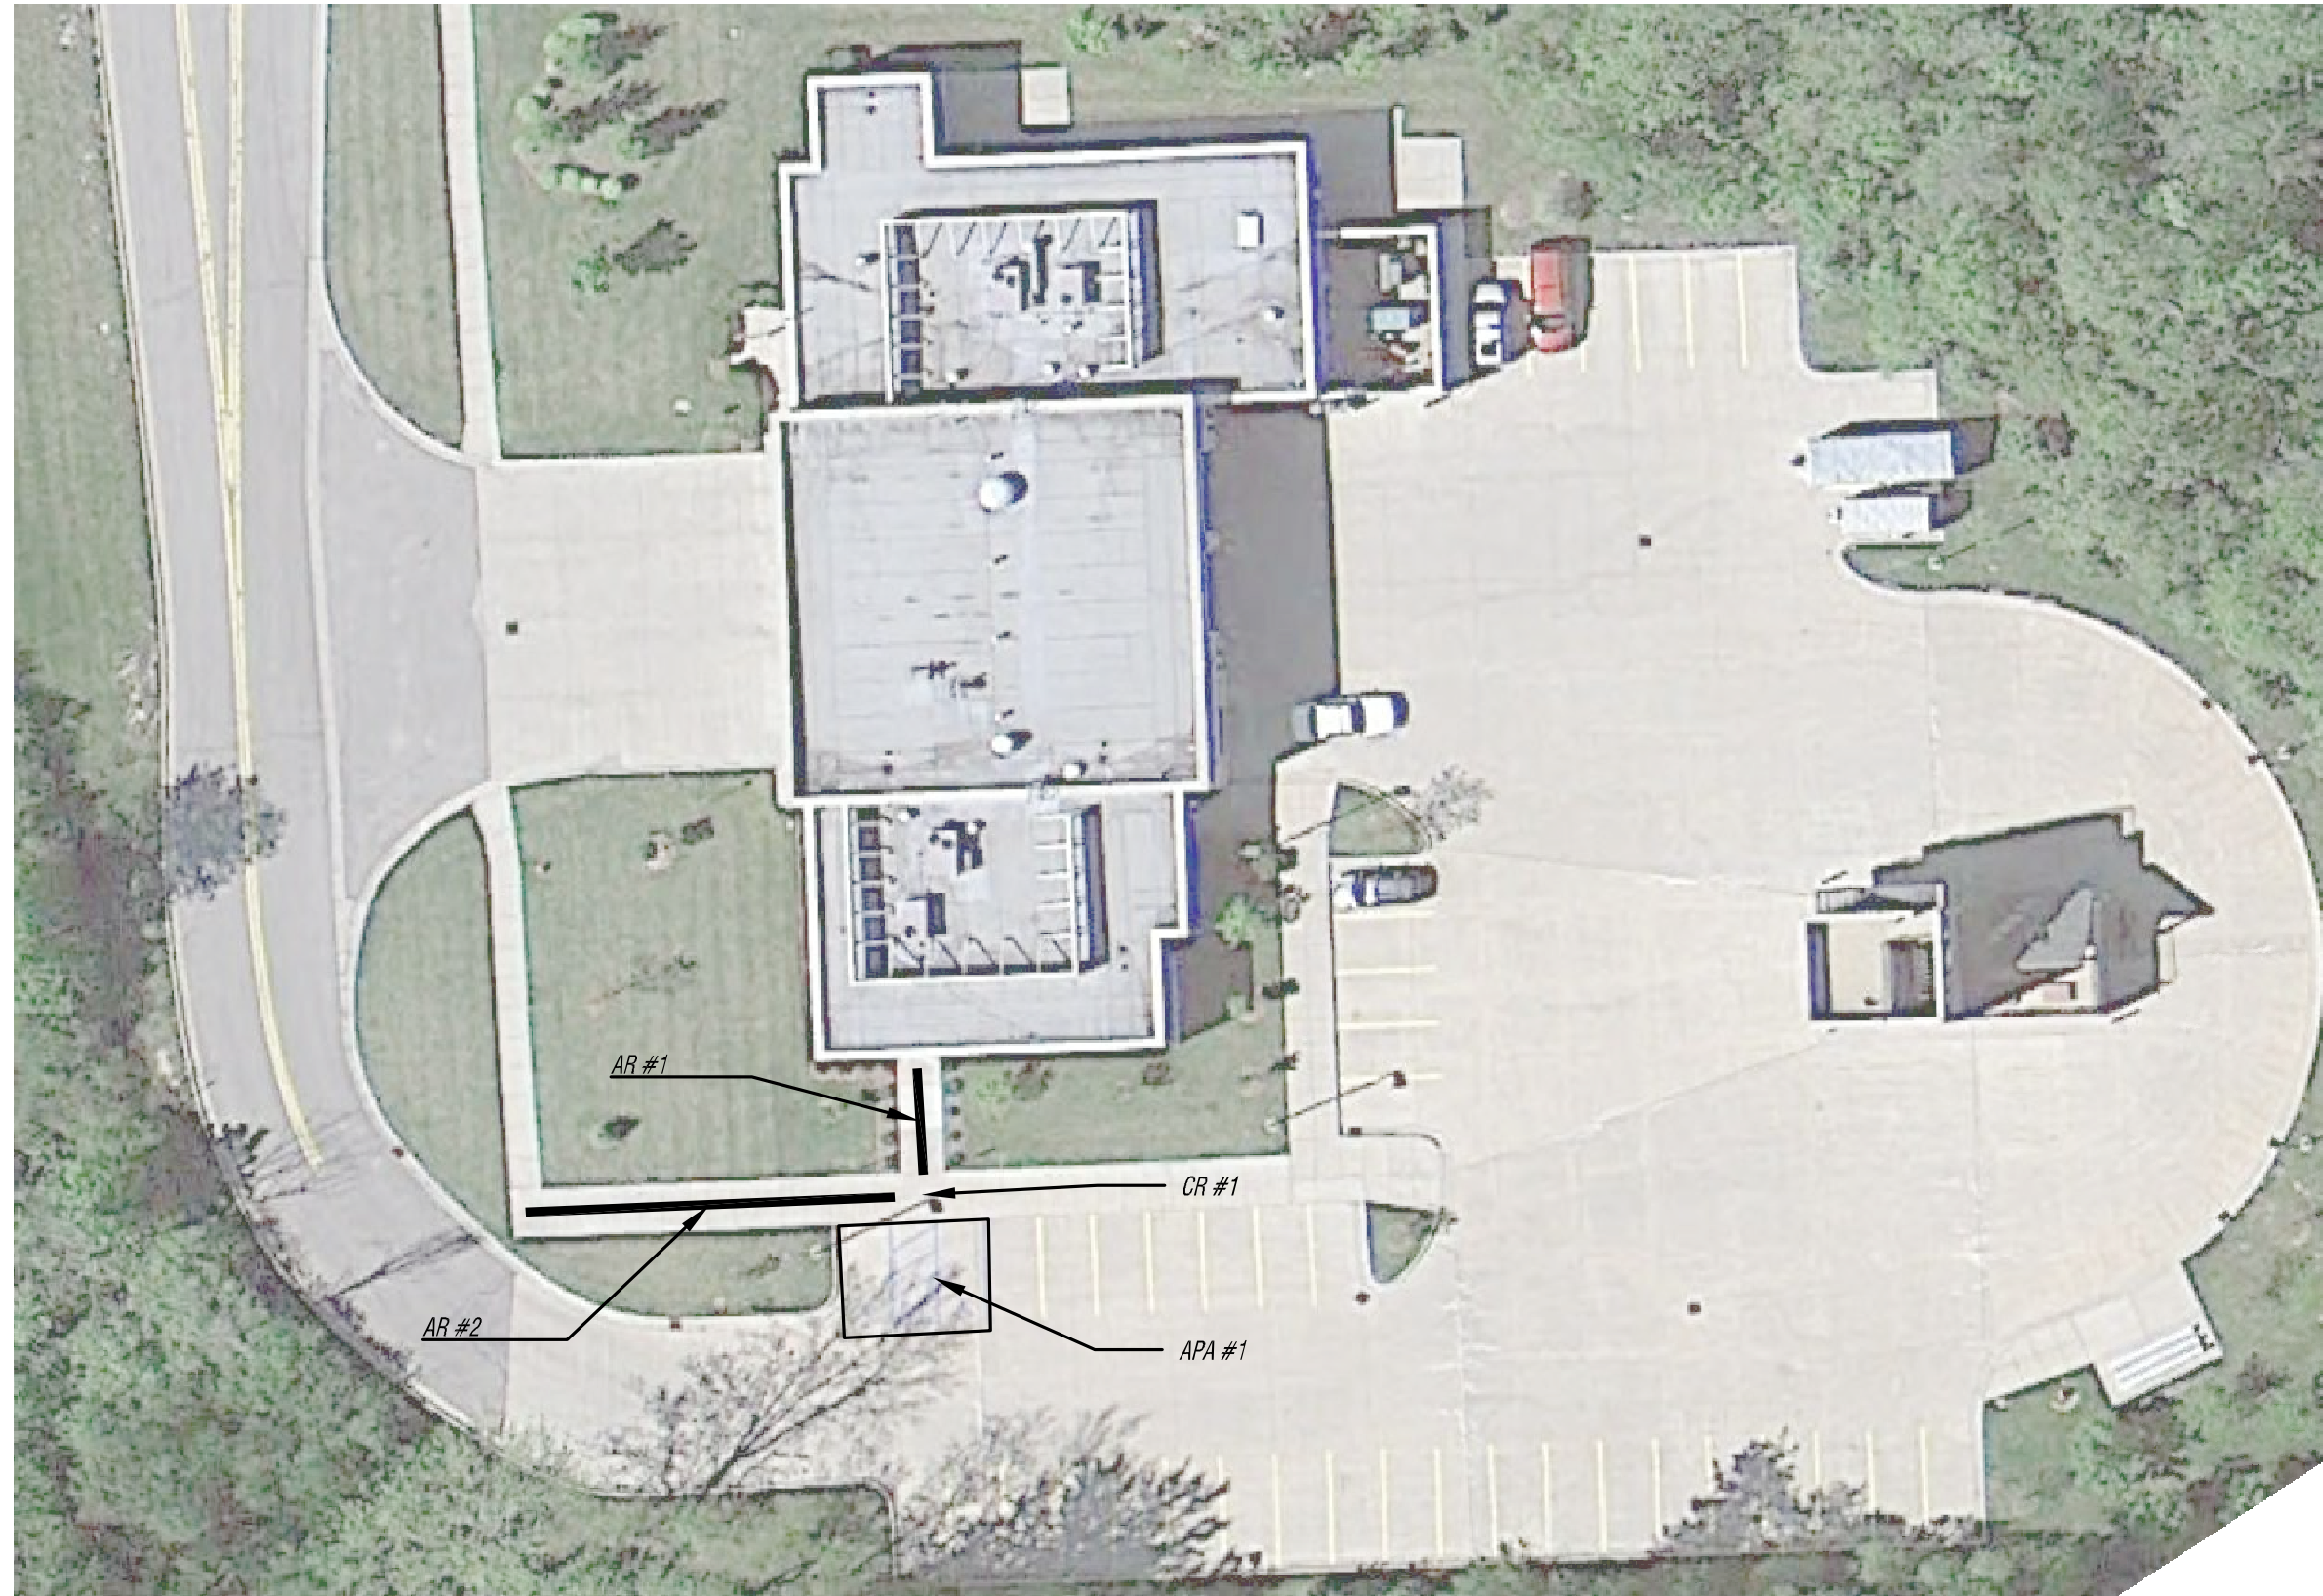
| Item # | Location | Element | Notes | Solution | 2010 ADA Standards |
|---|---|---|---|---|---|
| 10 | Accessible Route AR#2 - from Public Right-of-Way to AR#1 | Accessible Route | Running slopes are at or below 5.0% and cross-slopes are at or below 2.0%. However, the concrete sidewalk surface is experiencing minor heaves and joint spalls that are creating non-compliant changes in level and openings. | Seal all spalled joints/cracks and isolated flag replacement to correct heaved changes in level. | 403.3 |

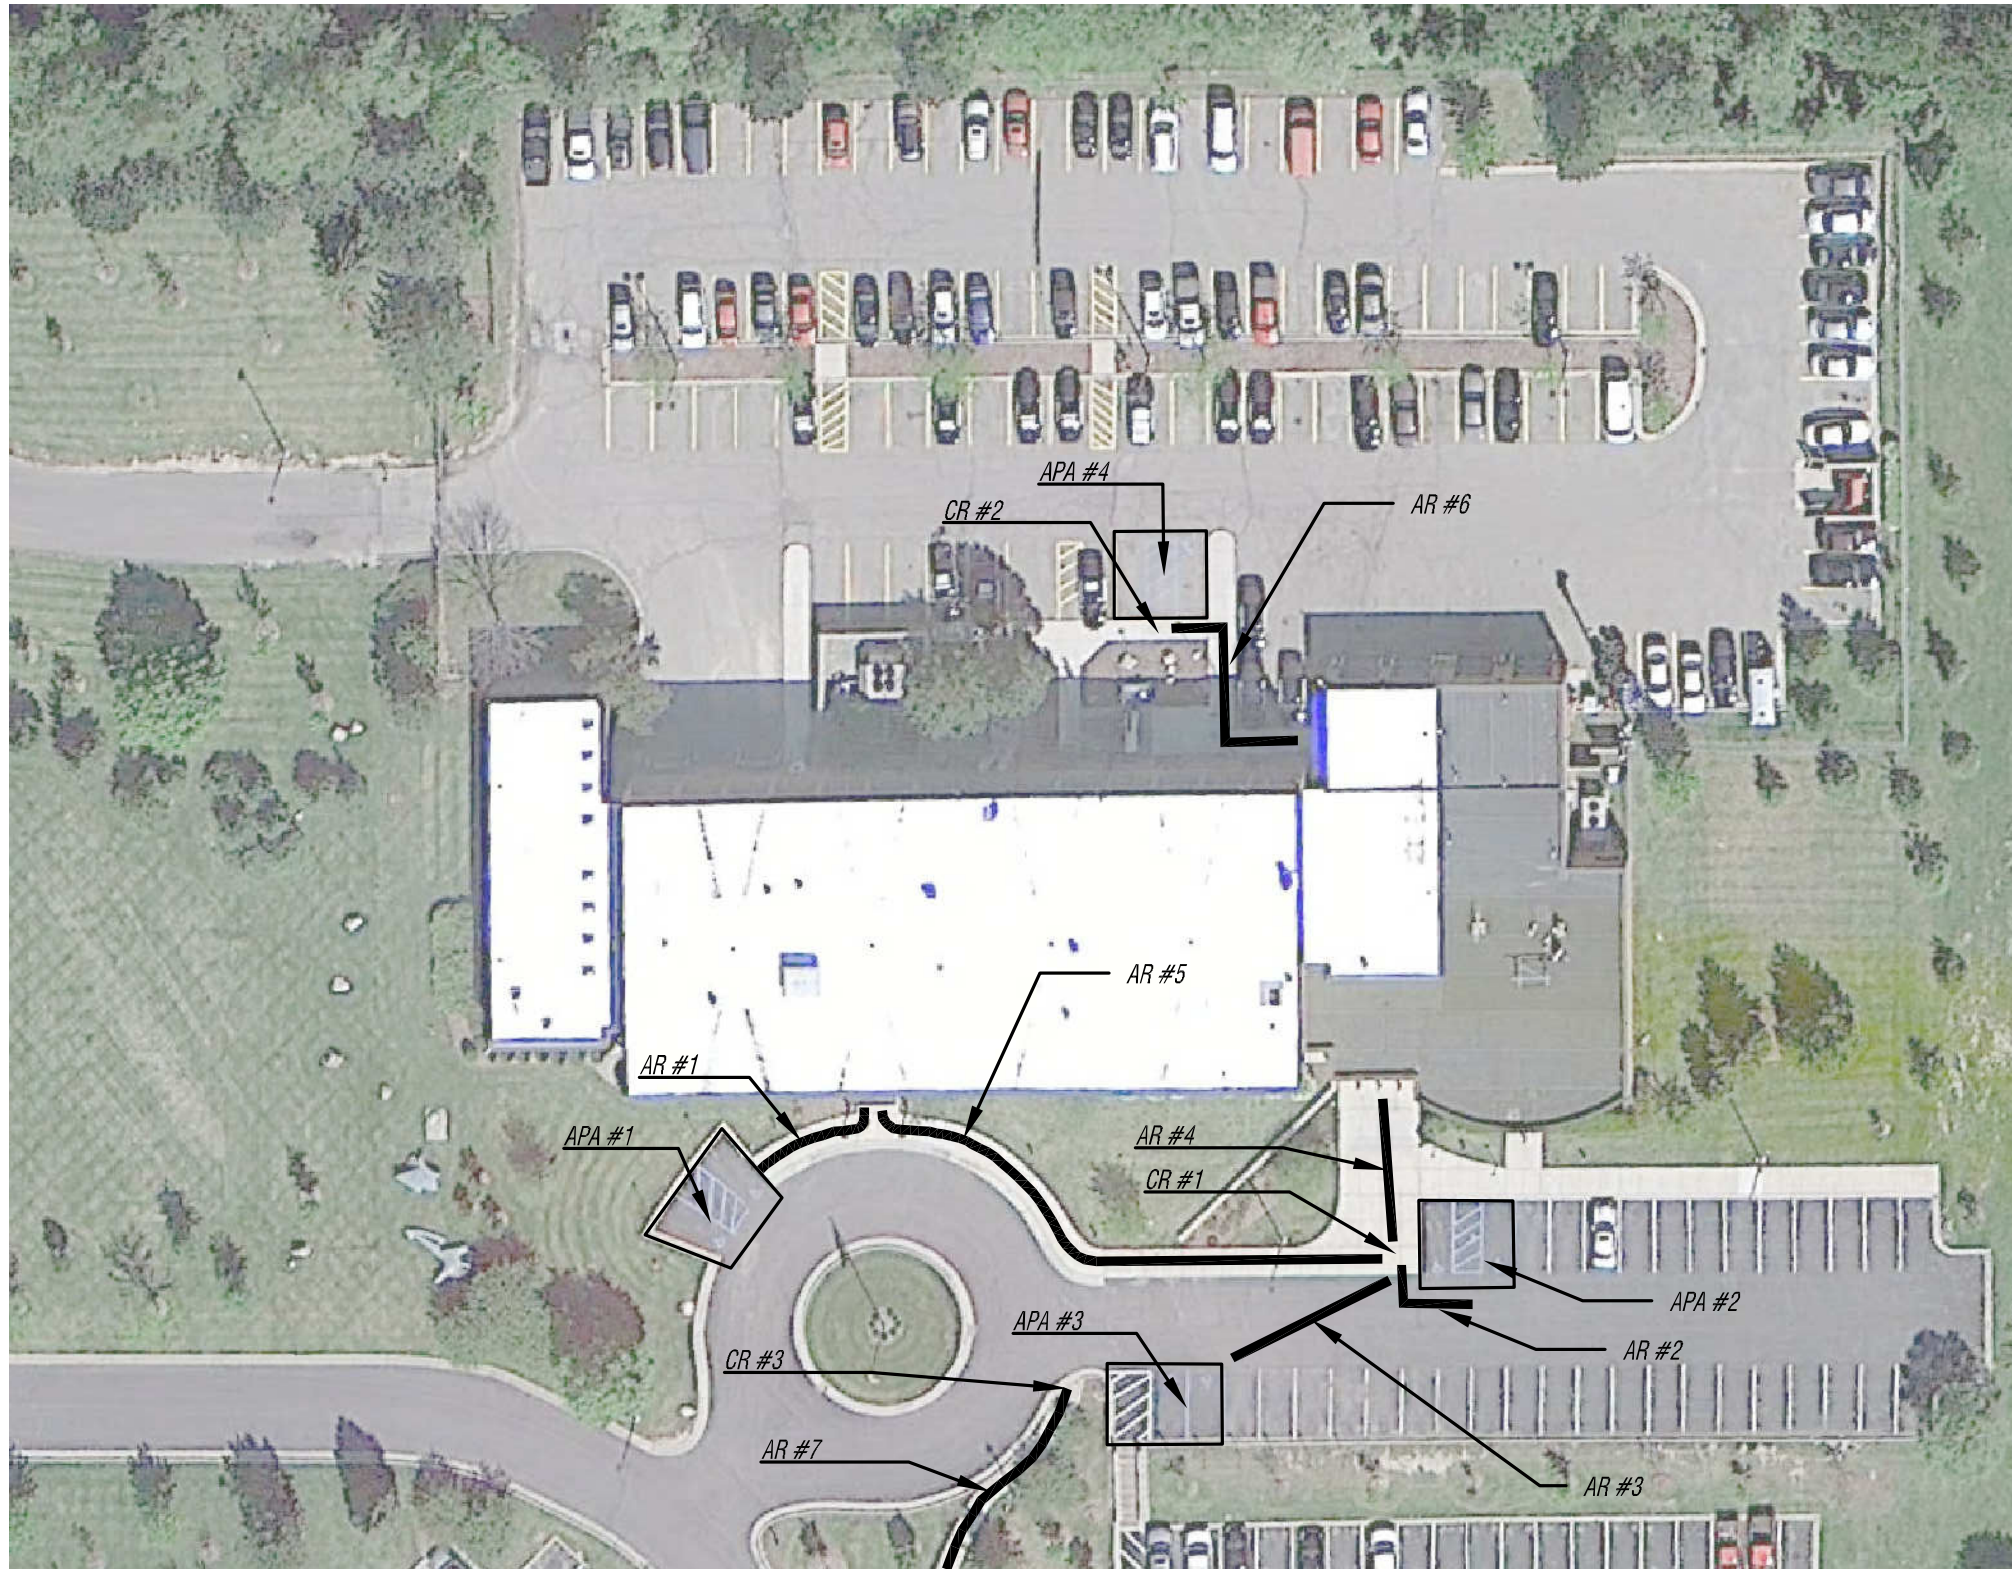
| 31 | CR#3 - from AR#7 | Curb Ramp | The concrete curb ramp has ADA compliant slopes. However, the concrete surface of the ramp has deteriorated, creating large openings and changes in level. | Replace concrete curb ramp to match existing compliant slopes. Replacing ramp will remove openings and changes in level. | 406.1 & 406.4 |
