# CITY of NOVI CITY COUNCIL

**Agenda Item D  
December 22, 2014**

**SUBJECT:** Approval to award an amendment to the engineering services agreement with Spalding DeDecker Associates for additional design engineering associated with the Beck Road Mid-Block Pedestrian Crossing project in the amount of \$6,697.

# Beck Road Mid-Block Pedestrian Crossing

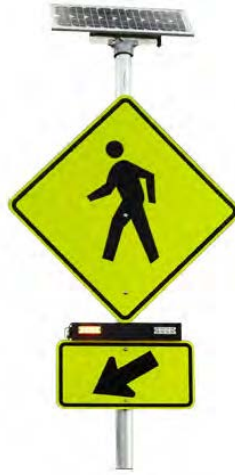
Another option that was considered, but is not currently recommended, is the use of Rectangular Rapid Flashing Beacons (RRFB). An RRFB (see photo, right) incorporates flashing lights with pedestrian crossing warning signs that will flash when activated to let motorists know a pedestrian is present. The information reviewed for RRFBs is inconclusive regarding whether the installation is appropriate for this proposed mid-block crossing. Many of the studies focus on wider 4-lane roads where a crossing would be more challenging. RCOC has indicated that driver expectancy should be considered, meaning that in areas where this type of facility isn't common, the use of the RRFB can lead to driver and pedestrian confusion, where motorists are unsure of what to do. Maintenance has also been identified as an issue with RRFBs (e.g. obtaining manufacturer's parts and service when needed, and false reports by motorists that the unit is not working properly).

One primary reason that an RRFB isn't recommended is the existence of sufficient gaps in Beck Road traffic, as verified by the study, provided a pedestrian refuge island is constructed. If not installed initially with a mid-block crossing, RRFBs can be easily added afterward if desired, at a cost of approximately \$15,000.

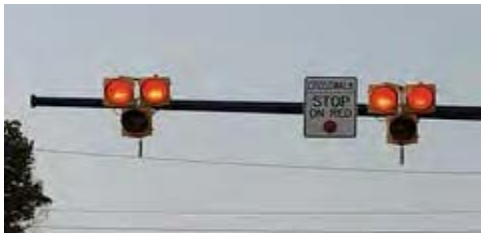
Another pedestrian crossing signaling system that is available, but hasn't been considered for this crossing, is the High-intensity Activated crossWalk (HAWK) system. The HAWK (see photo, left) would be appropriate at a crossing with a higher pedestrian volume than what is expected at this crossing.

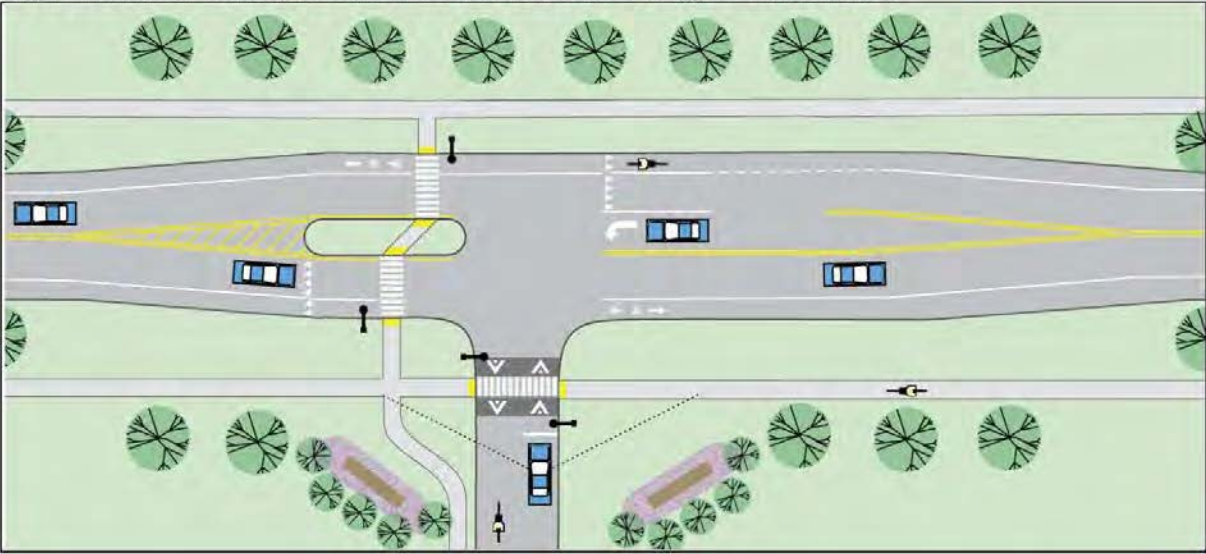
**Fig. 5.47AA. Subdivision T-Intersection Design Guidelines**

The proposed mid-block crossing would closely resemble Figure 5.47AA (below) from the non-motorized master plan.

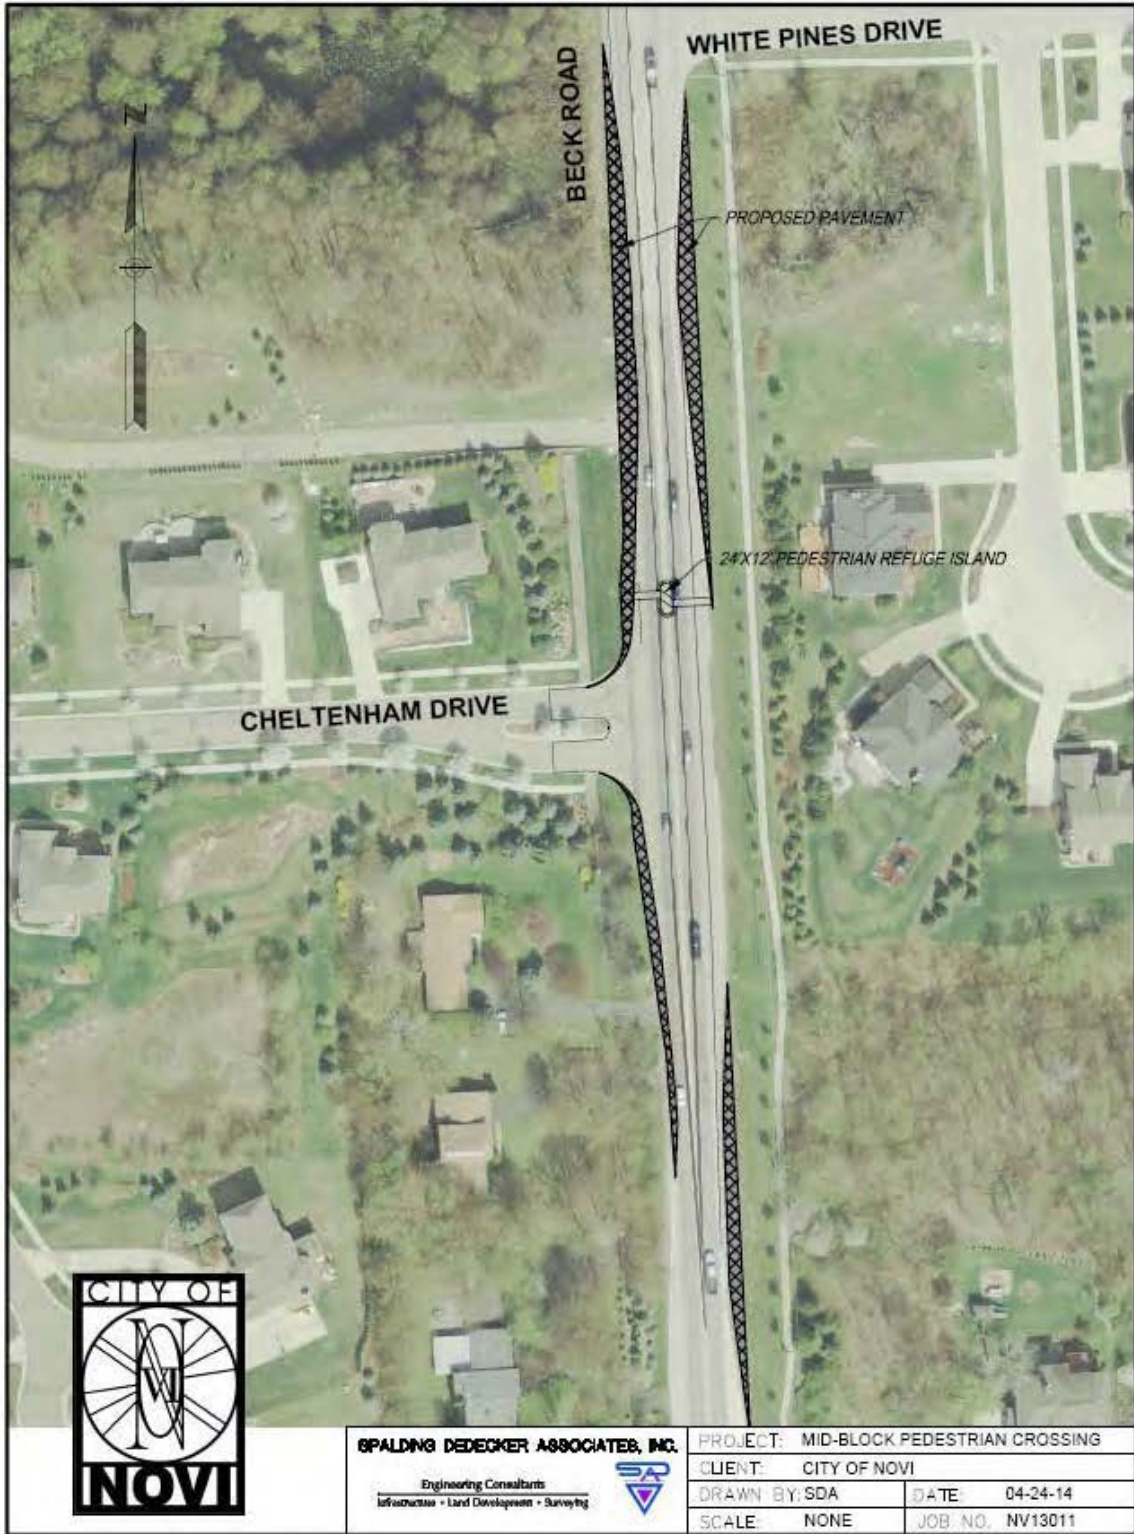
To facilitate the construction of a refuge island at this location, the northbound and southbound lanes of Beck north of Cheltenham will need to be flared around the island location via widening the pavement on the east side of Beck Road and appropriate pavement markings. A street light (or lights) should be installed on both sides of the road at a crossing. The existing light at Cheltenham should be sufficient for the west half of the crossing, but a light will need to be added on the east side of Beck Road. Signing (pedestrian crossing ahead, and pedestrian crossing location) is also required to be placed to indicate the potential for pedestrian crossing. See the attached figure on the following page for a conceptual layout of the island and pavement markings.

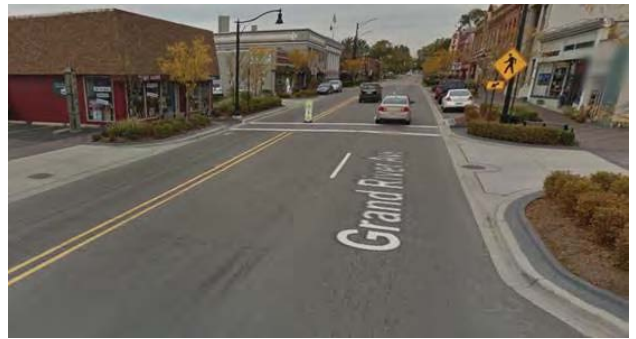
#### Crossing Type A:

- Marked special emphasis crosswalk (See MDOT PAVE 945 series)
- Standard pedestrian warning signs (W11-2) (See MDOT Traffic Sign Design, Placement and Application Guide). Evaluate need for advanced signing.
- If the location is a designated school crossing then standard school crossing signs (S1-1) should be used.

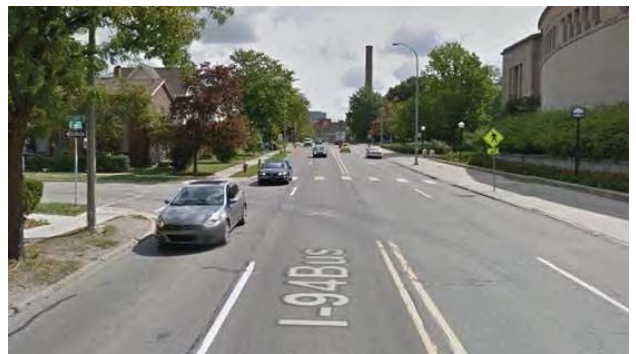
#### Crossing Type B:

- Marked special emphasis crosswalk (See MDOT PAVE 945 series)
- Standard pedestrian warning signs (MDOT Traffic Sign Design, Placement and Application Guide). Evaluate need for advanced warning signs.
- Geometric improvements (such as median nose extensions, curb extensions, pork chop island, tighter curb radius or median refuge islands) or consider pedestrian activated Rectangular Rapid Flashing Beacons (RRFB) if criteria are met in Figure 3a or 3b (see page 11). Submit form 1597 to MDOT Signal Operations to request a study for any electronic pedestrian device.
- Consider use of in-street yield to pedestrian crossing sign (R1-6) in low speed urban setting if the local unit of government has adopted the Michigan Uniform Traffic Code for Cities Townships and Villages.
- Additional pavement markings may be required such as double yellow centerline

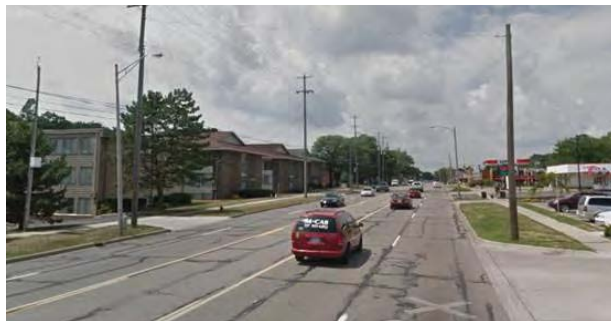
#### Crossing Type C:

- Where the posted speed is greater than or equal to 45 mph, determine if modifications can be made to the geometrics of the roadway or signal timing adjusted to calm traffic to reduce travel speeds (85th) thus allowing the road to have a lower the posted speed limit and a raised median and/or pork chop island can be installed. A lower posted limit must be supported by a speed study. If so, go to Crossing Type B
- If not possible or if pedestrian volumes fall above the Rectangular Rapid Flashing Beacon (RRFB) limit line on Figure 3a or 3b, go to Crossing Type D

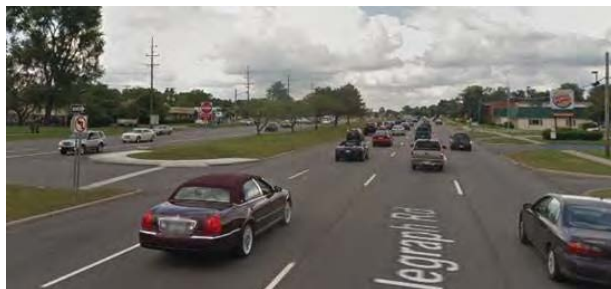
#### Crossing Type D:

- Crossing has the following configurations:
  - 4 Lanes with speed greater than or equal to 45 mph and ADT greater than or equal to 12,000 vpd
  - 5 Lanes with refuge island or 4 lane with raise median with speed greater than or equal to 45 mph and ADT greater than or equal to 15,000 vpd
  - 5 Lanes with speed greater than or equal to 45 mph and ADT greater than or equal to 12,000 vpd
  - 6 Lanes with speed greater than or equal to 40 mph and ADT between 1,500 and 12,000 vpd or ADT greater than 12,000 vpd for all posted speeds.
- 3 or more through lanes in a given direction and posted speed 40 mph or greater.
- Consider the Pedestrian Hybrid Beacon (PHB), pedestrian traffic signal or grade separated pedestrian crossing. Submit form 1597 to MDOT Signal Operations to request a study for any electronic pedestrian device.
