CITY OF NOVI  
ADA COMPLIANCE TRANSITION PLAN  
CITY-OWNED FACILITIES  
MARCH 2014

SDA Job No. NV13006.0C

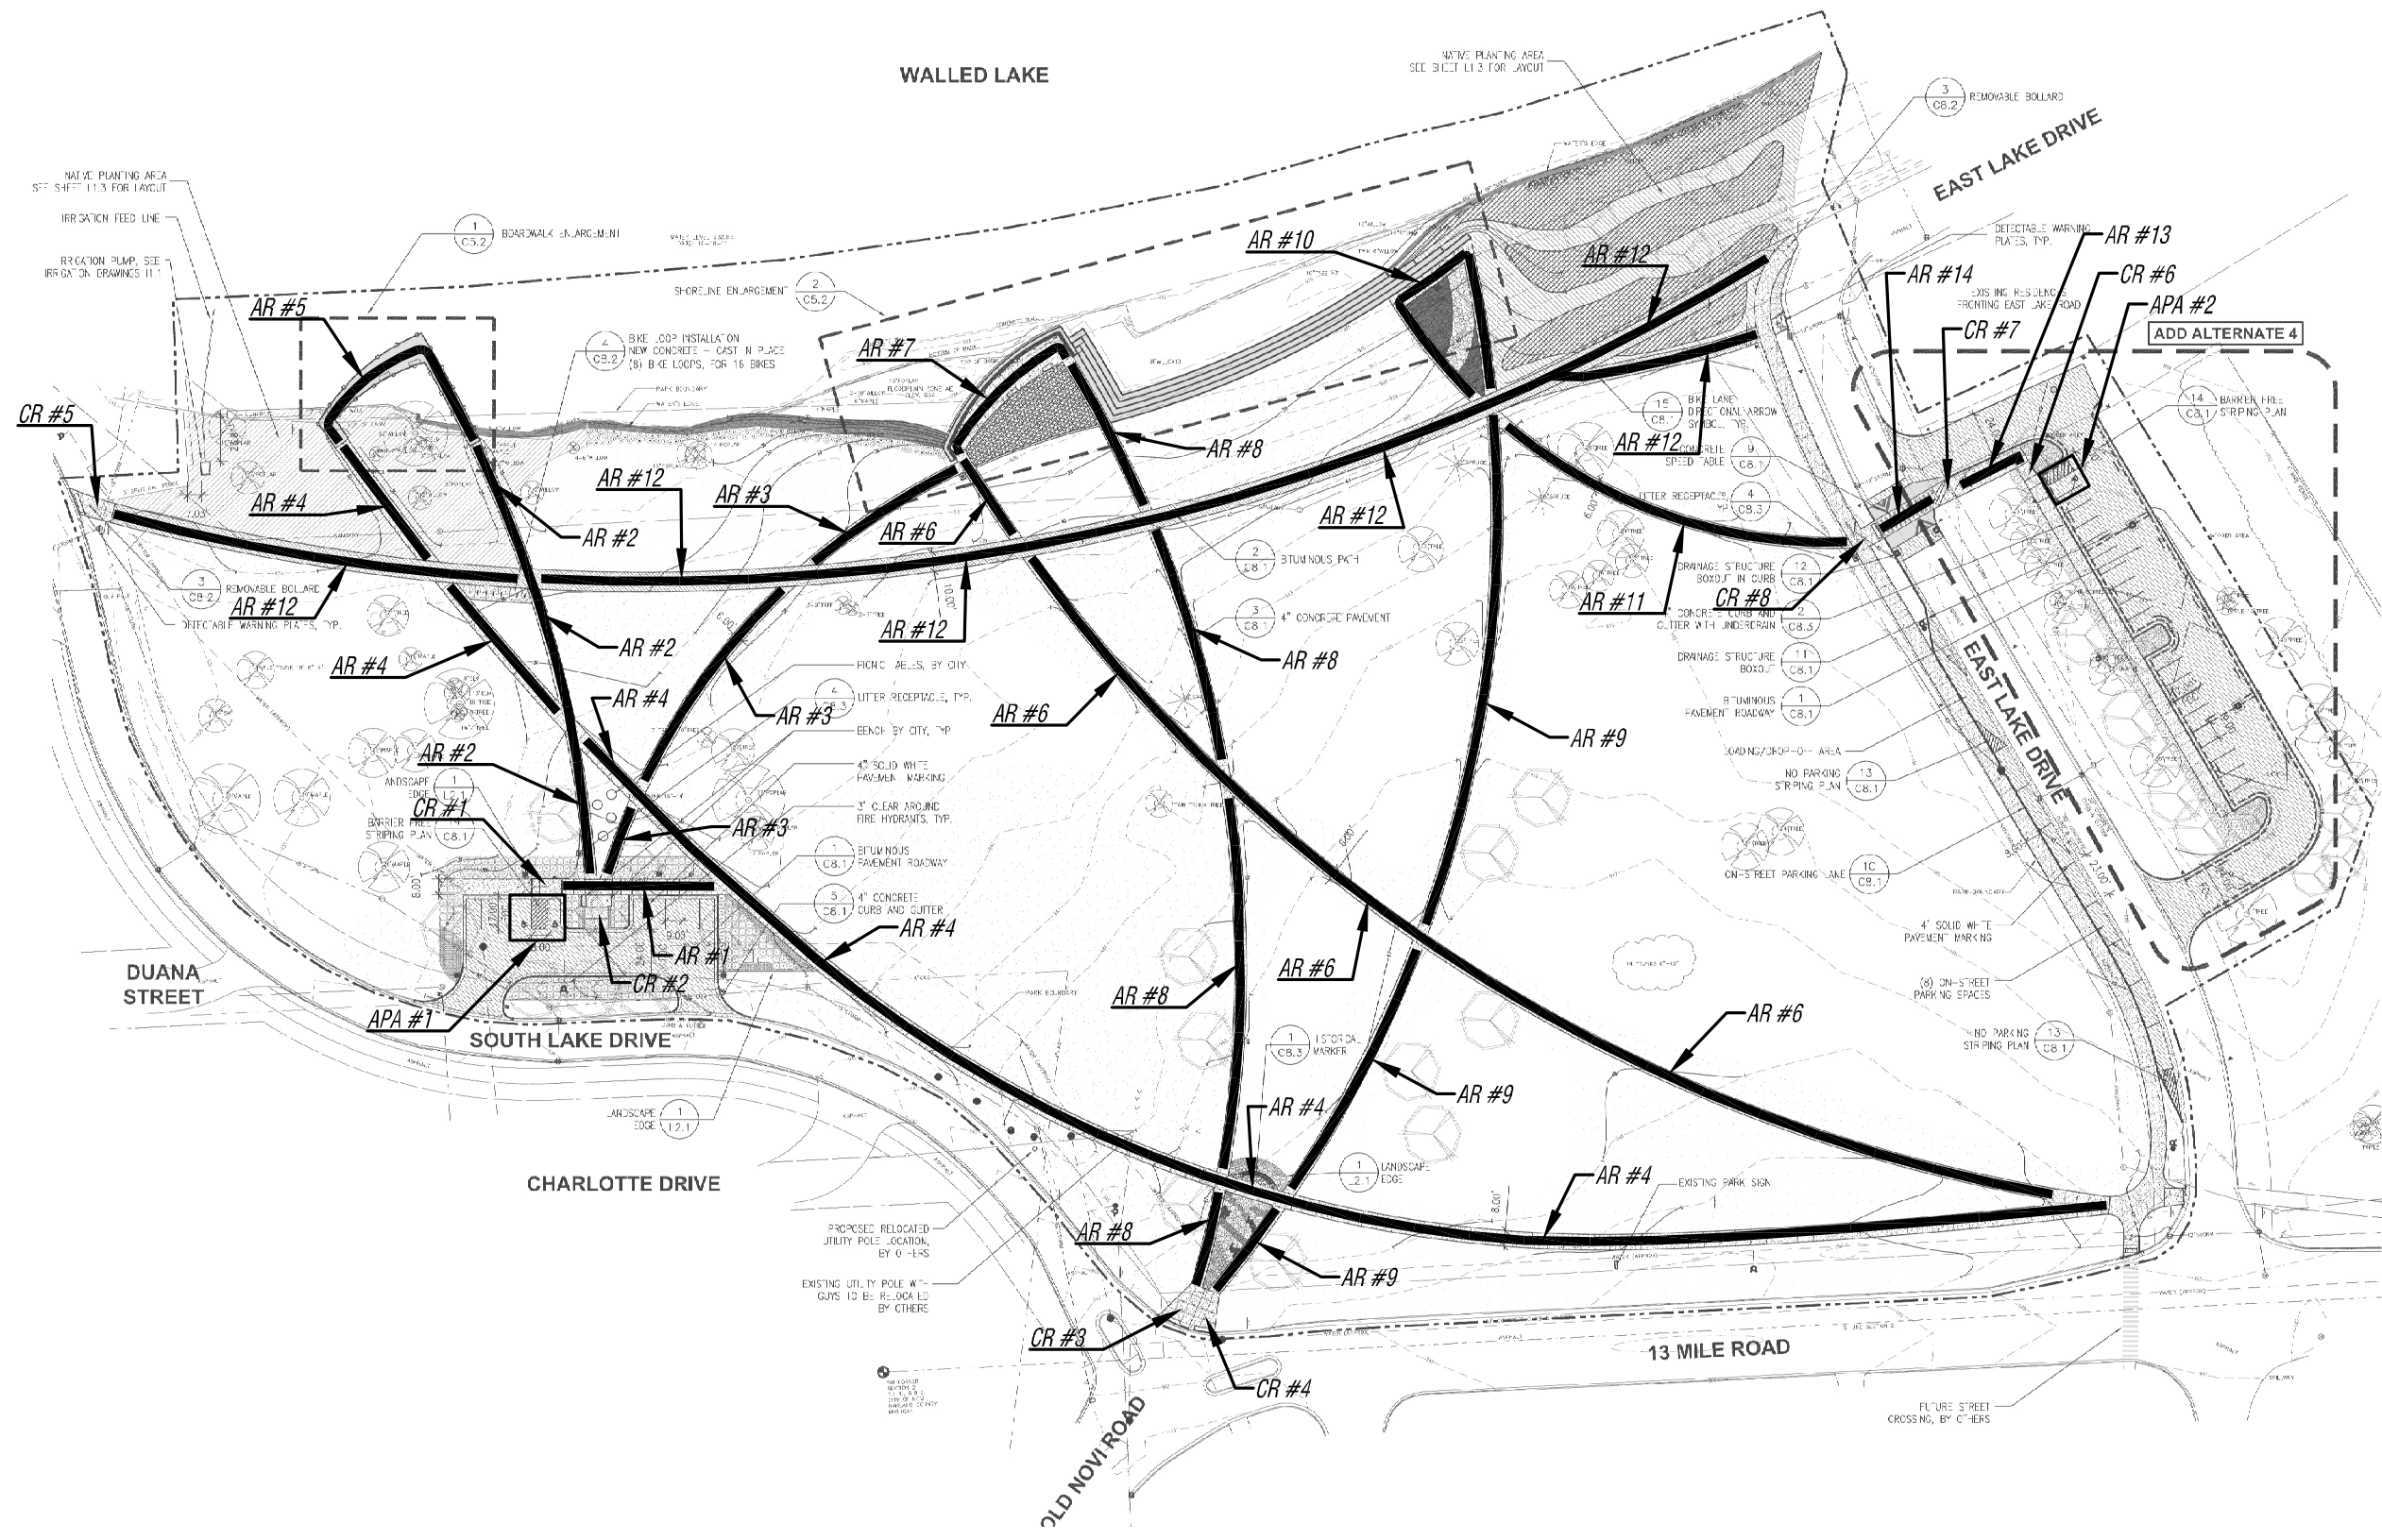
| 32 | Accessible Route AR#14 - from CR#7 to CR#8 | Accessible Route | Running slopes within the concrete pavement accessible route are at or below 5.0% and cross-slopes are at or below 2.0%. | No action required. | 403.3 |

| 33 | Curb Ramp CR#8 - from AR#14 to AR#11 | Curb Ramp | Running slopes are at or below 8.3% and cross-slopes are at or below 2.0%. | No action required. | 406.1 & 406.4 |

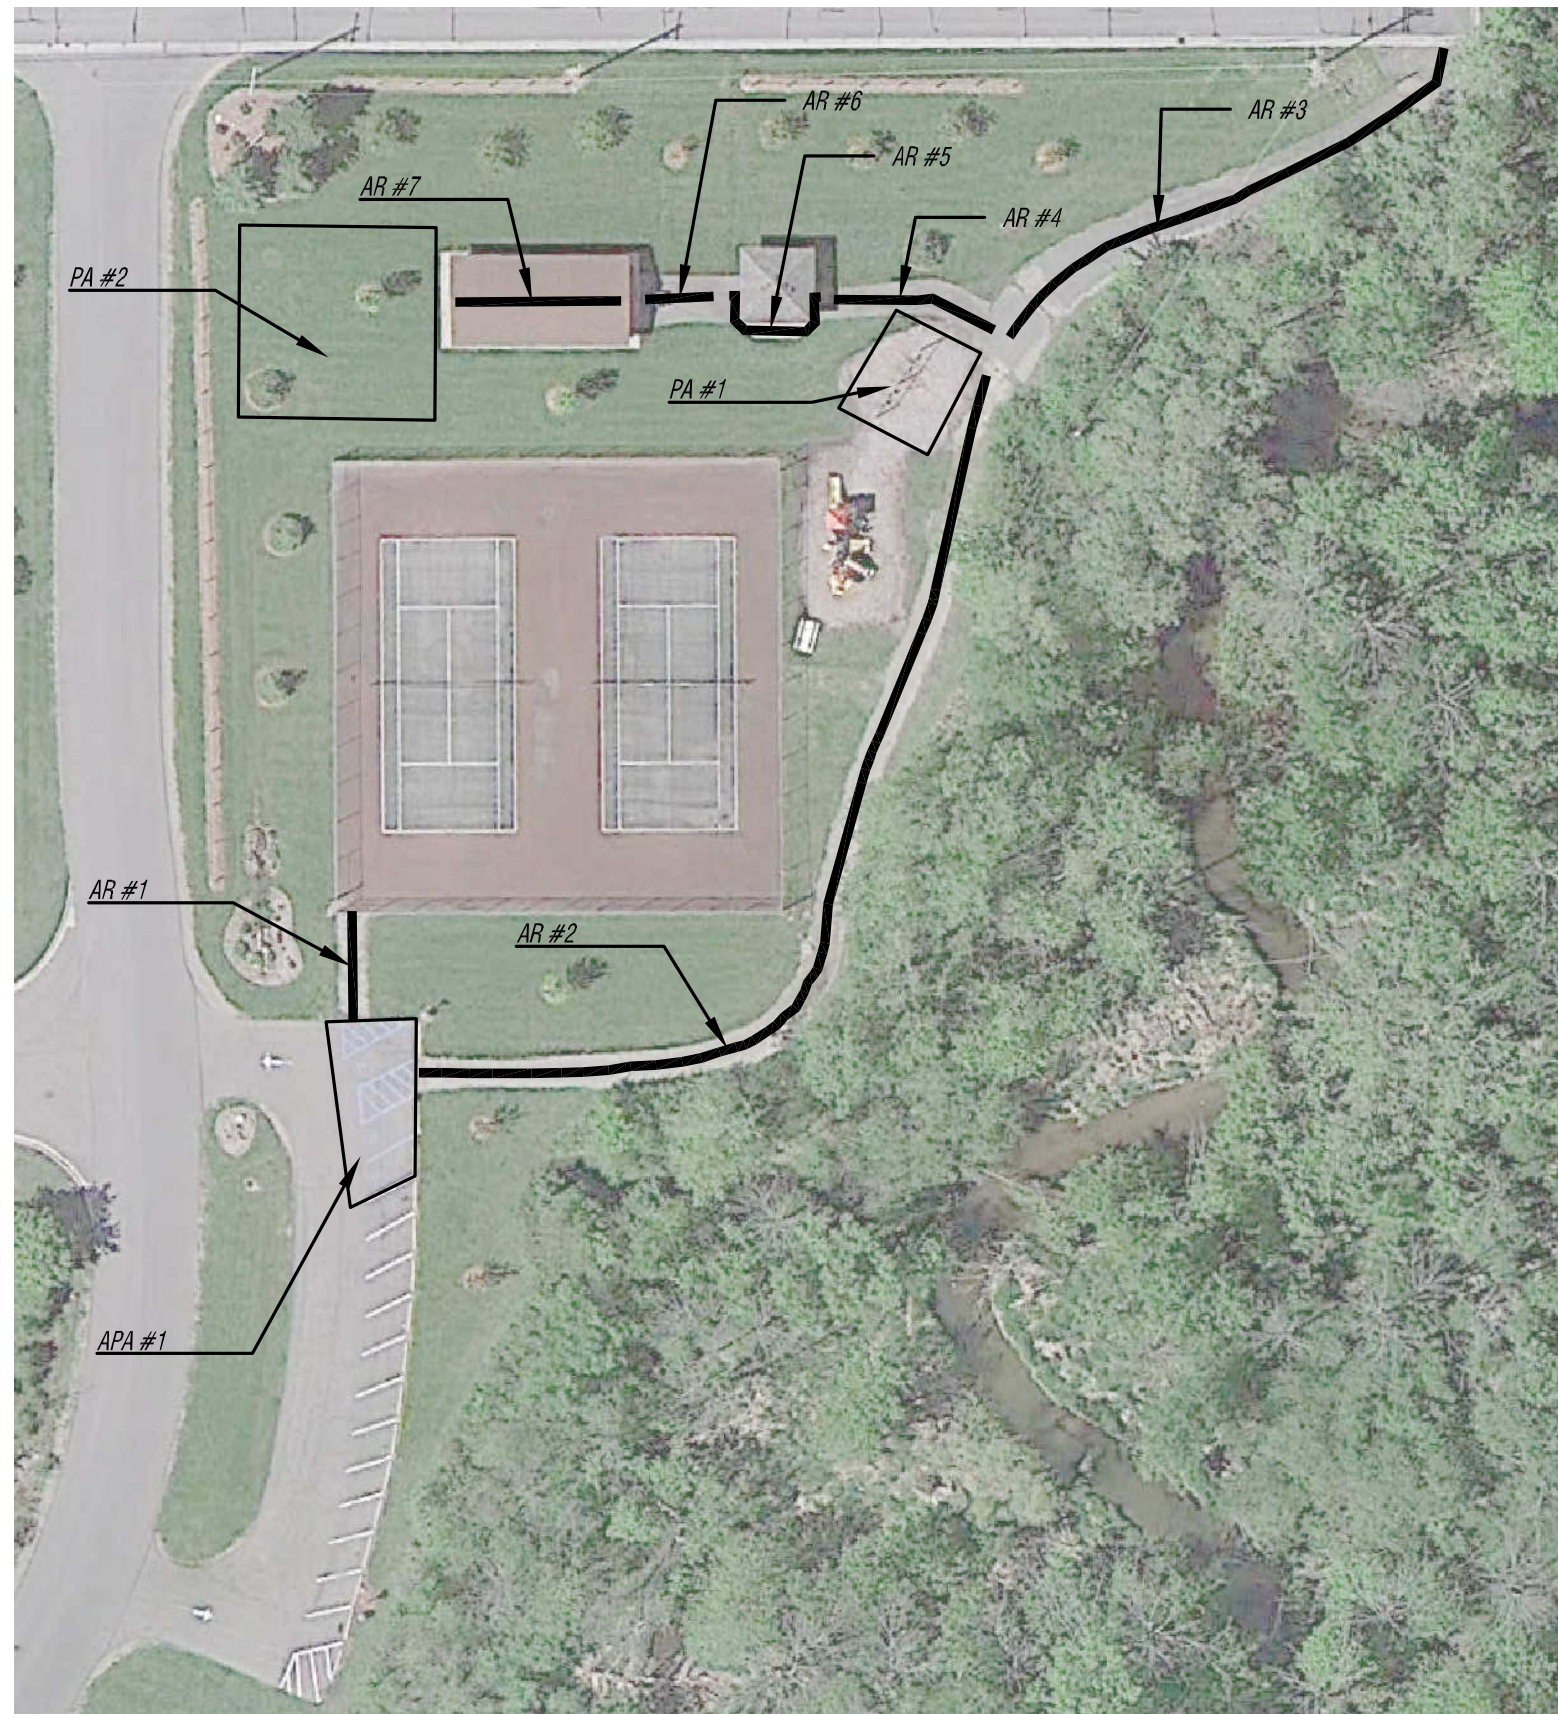
| | Play Areas | | | | |
|---|---|---|---|---|---|
| 16 | Play Area PA#1 | Play Area | Play area surface is comprised of woodchips and is level with surrounding surfaces with no borders, providing an accessible route into the area. | No action required. | 1008.1 |
| 17 | Play Area PA#2 | Play Area | Play area surface is comprised of woodchips and is surrounded by a plastic border. A 4' wide concrete ramp is provided leading from the concrete canopy area to the play area, but has running slopes exceeding 8.3% and side flares that are too steep. | Remove existing ramp and install new ramp with ADA compliant slopes to maintain an accessible route into the play area. | 1008.1 |

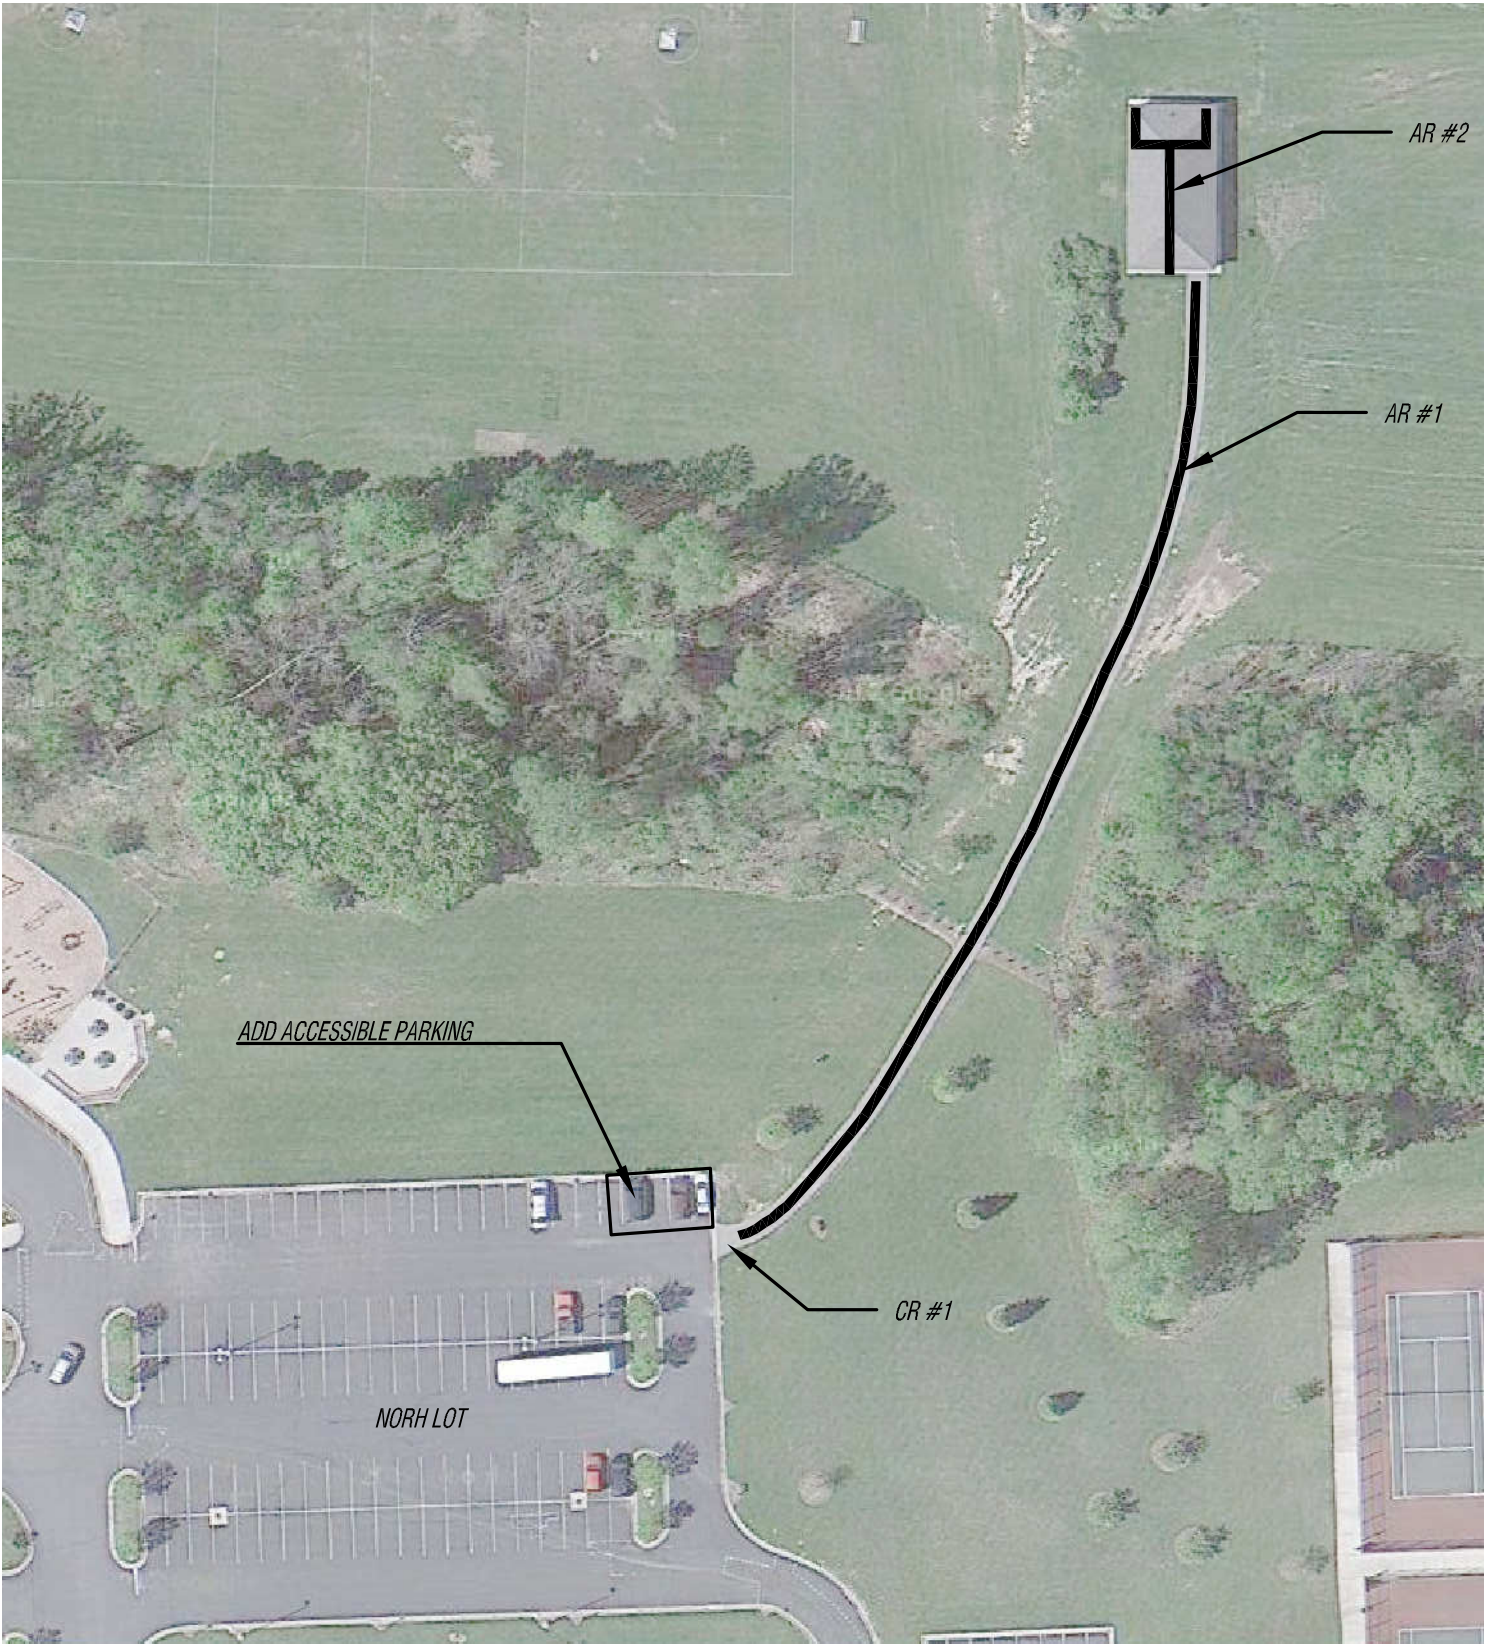
| Item # | Location | Element | Notes | Solution | 2010 ADA Standards |
|---|---|---|---|---|---|
| 5 | Accessible Route AR#1 - from CR#1 to AR#2 | Accessible Route | Portions of the asphalt pathway were found to have cross-slopes exceeding 2.0%, measured up to 3.6%. Other portions of the asphalt pathway were measured to have running slopes exceeding 5.0%, measured up to 6.8%. | Replace portions of the asphalt pathway to provide a maximum running slope of 5.0% and a maximum cross-slope of 2.0%. | 403.3 |
| 6 | Accessible Route AR#2 - from AR#1 | Accessible Route | The concrete pavement underneath the canopy is level with slopes at or below 2.0% in all directions. However, cracked and heaving concrete flags at the northeast and northwest corners of the concrete pad at the two bathrooms entrances are creating significant changes in level. | Replace the concrete flags at the northeast and northwest corners near the bathrooms entrances to provide smooth surfaces free of lips and changes in level. | 403.3 |
