Facility Condition Assessment

Prepared for the City of Novi

April 7, 2025

Police Station Building

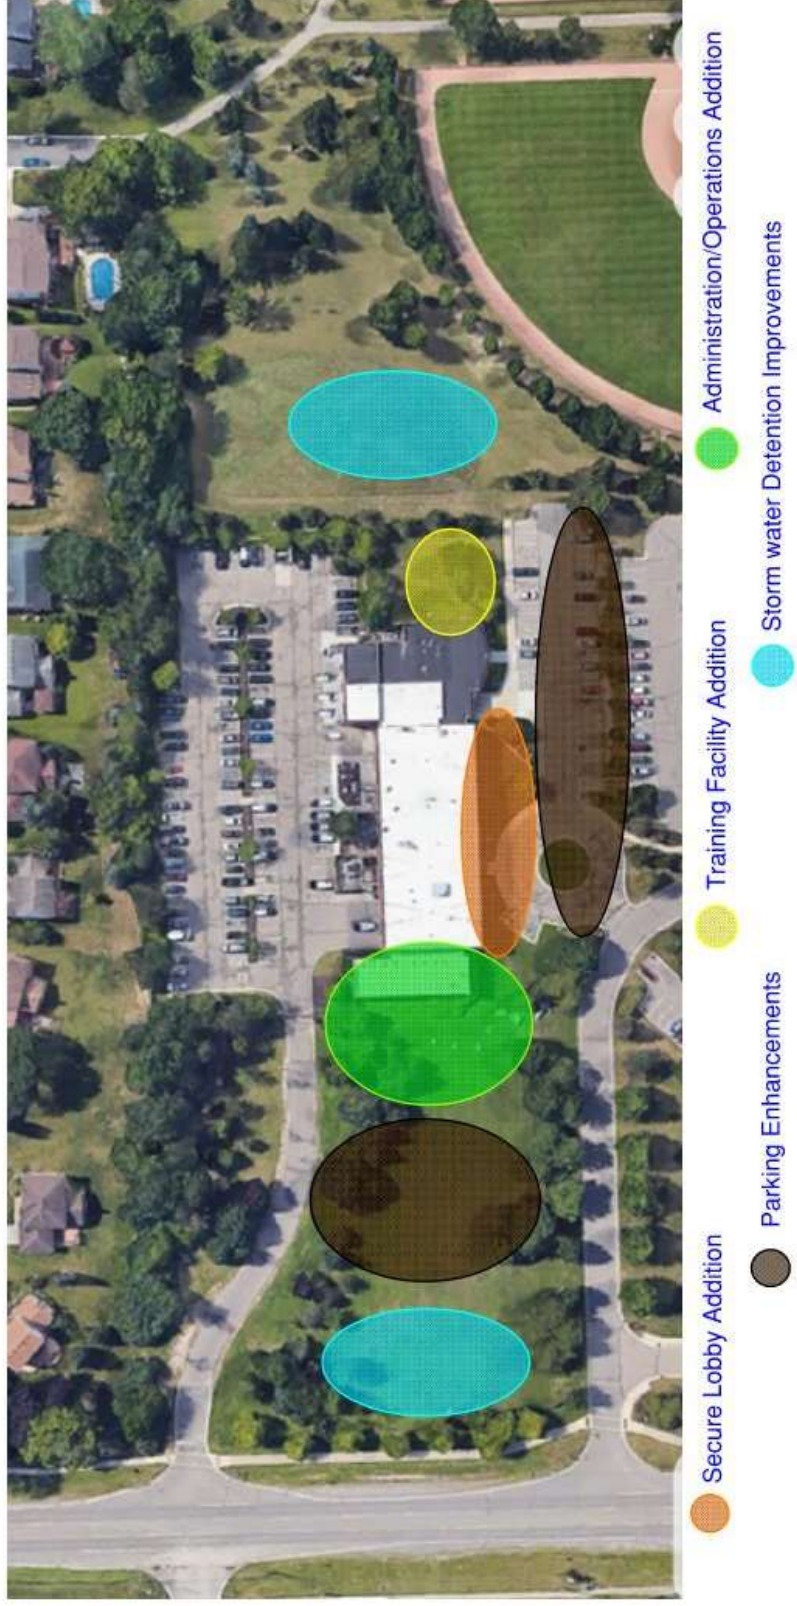
Conceptual Site Plan for Enhanced Police Facility Renovations and Additions

Existing Building Renovations : ~38,000SF @ ~\$400/SF to ~\$550/SF = ~\$15M to ~\$20M

-Phased construction with impacts to site access, parking and building operations, confined to the existing site layout and potentially restrict programming efficiencies.

Total Conceptual Budget: ~\$40M to ~\$50M

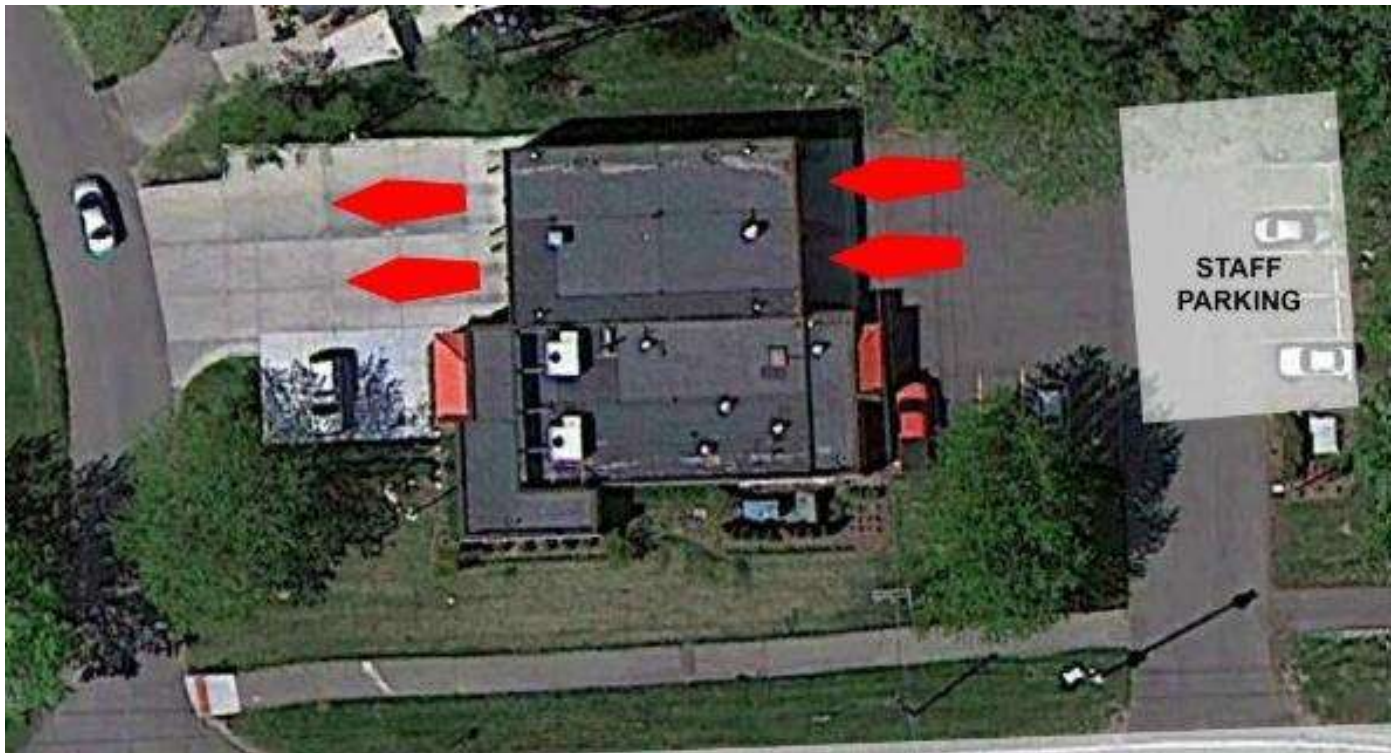
Site Plan

Address:	1919 Paramount
Year Built:	1981, 2009 addition
Square Footage:	5,117
Site Area:	0.62 acres
Parking Spaces:	14
Stories:	1
Basement:	No
Elevator(s):	No
Exterior Façade:	Brick
Roof:	Single Ply
Fire Protection:	Partial
